Batteries & Energy Storage Technology

No. 67
Winter 2020

Letting the *cat* out of the bag

Pete DeMar, an independent battery testing expert and founder of Battery Research and Testing Inc, shares his experiences with catalysts, sheds light on issues involving early capacity or capability losses with VRLA batteries—and reveals the tricks of the trade in turning problems around. Inducted into the Battcon Hall of Fame, Pete is the inventor of the internal ohmic value recovery (IOVR+™) process.

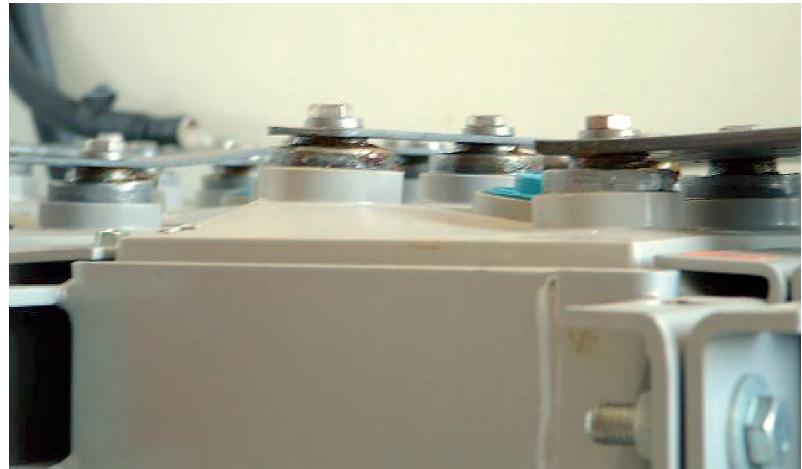
This battery was a 24V string, date code 3/92, and located in a microwave site. It was to be replaced based upon its capacity test result on 18 May 2000 of 32% of its 3-hour rating (58 minutes). This equated to a site support time of 4.7 hours. That site required 8 hours of battery run time. We were then brought into this as a demonstration project for this user, and performed our initial inspection and IOVR process on 14 July 2000. As can be seen in **Fig 1**, these cells were in

Fig 1: Extensive positive plate growth pushing cover upward around positive post.

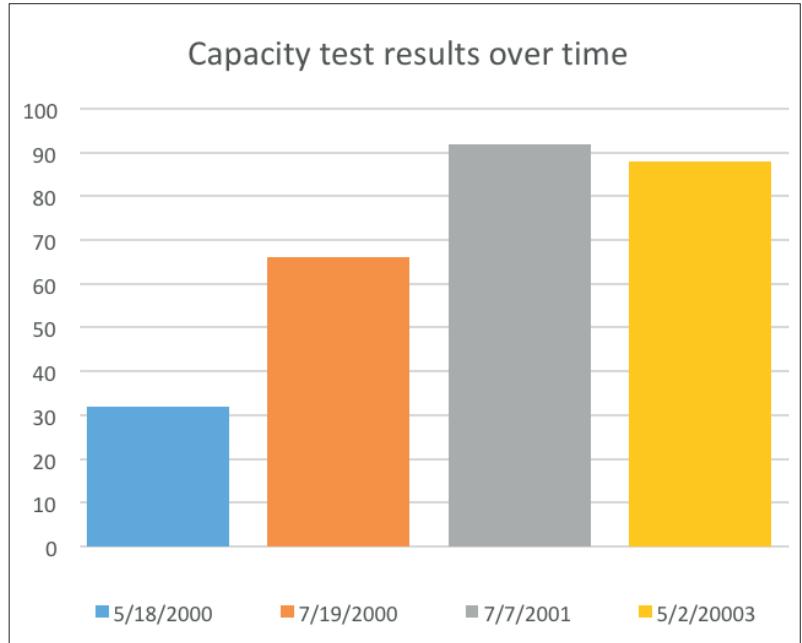
Fig 2: Capacity changes over time.

Also of note is that the float current as measured during their original site visit and test was 2.4A and on 2 May 2003 it had been lowered to 0.8A. The float current is a huge indicator of internal issues with these batteries. **Fig 2** shows the capacity changes over time.

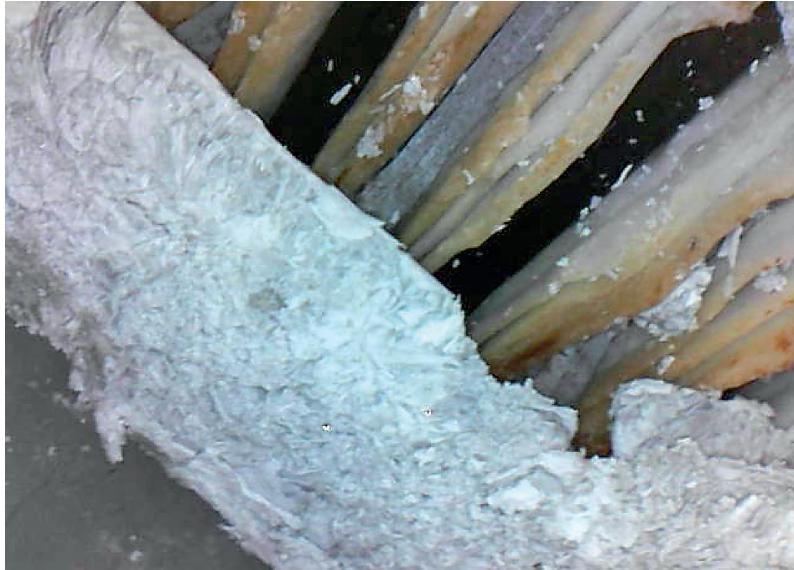
Fig 3: VRLA Negative bus breaking down observed with borescope. Battery on float.

21. With VLA batteries the predominant failure modes revolve around the positive elements.
22. With VRLA cells a borescope is an invaluable tool to diagnose abnormal issues. See **Fig 3**.

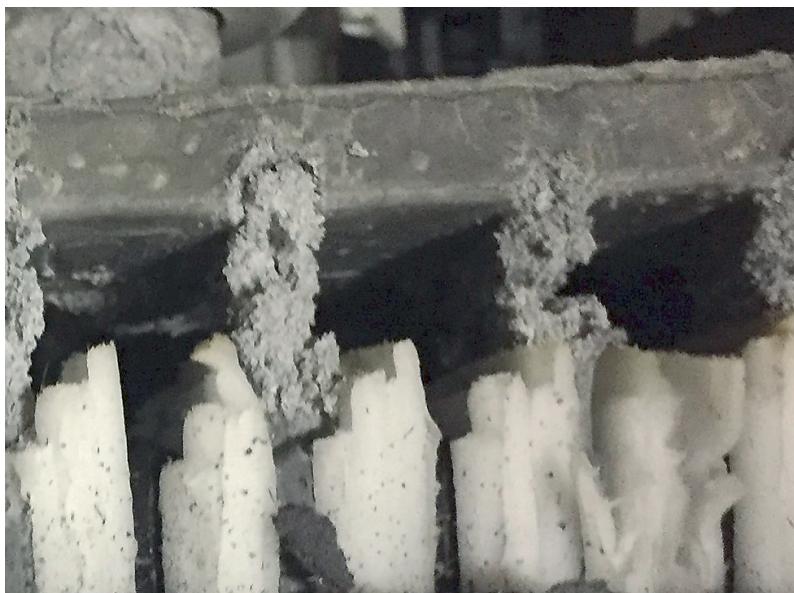
Fig 4: Severe negative tab failure, found upon dissection after initial alert with borescope. You can see the negative post/pillar also is decaying.

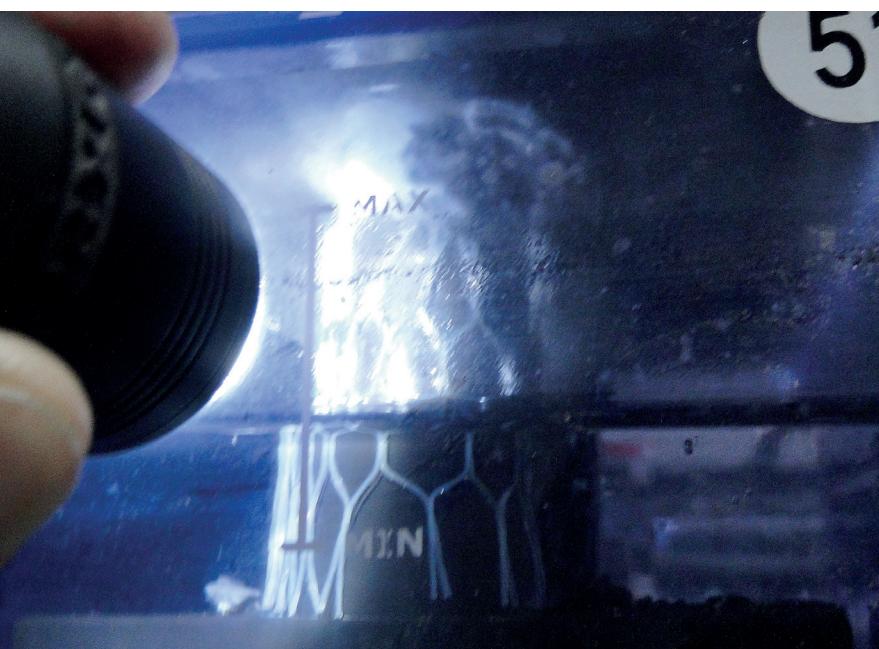
Figs 5-7 show the internal post seal failure from a number of cells in one particular battery string. This is an OPzS battery, that is less than 6 years old and on float service at a power plant. It was well maintained and just a little over a year prior to our inspection (May 2019) the battery had passed its load test.

Figs 5 & 6: VLA positive internal post seal failure discovered with a flashlight.

However, in some cases, as in these, the electrolyte gets past the internal positive post seal and then causes the post/pillar inside that space to be attacked. The post/pillar starts to corrode/degrade and it expands. When it expands it puts more pressure on that plastic post seal and the plastic cracks.

As the problem continues to degrade, more plastic ruptures and it goes on and on. While this degradation is occurring, the resistance of that post/pillar increases and becomes more of a voltage dropper.

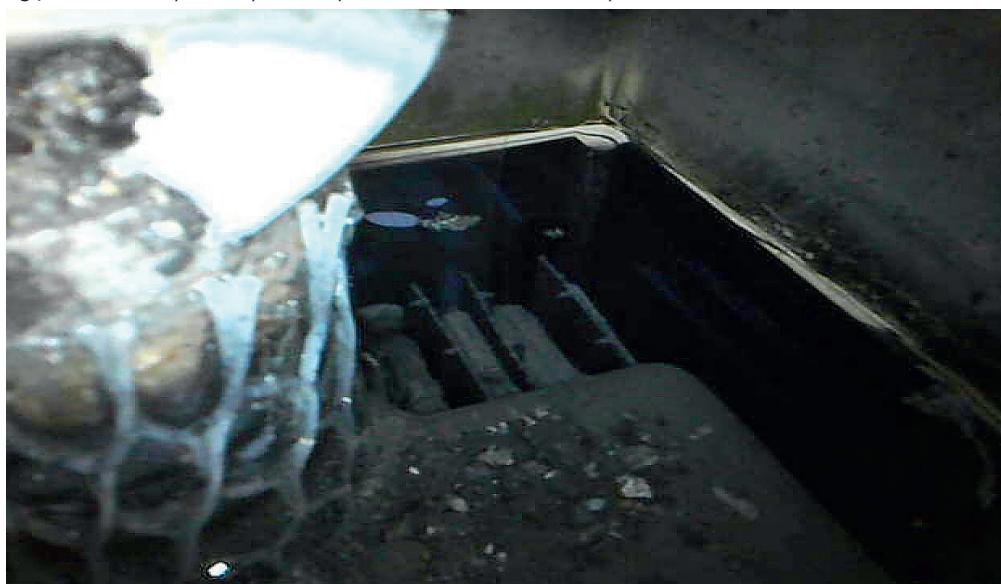
Fig 7: VLA internal positive post seal failure observed with borescope

because the unit had tripped, which should not have been a problem, but one cell in the battery failed open, and the lube oil pump stopped pumping oil to the bearings, so the generator came to a grinding halt. No one had any idea of why that occurred, after all, all of the inspections and the capacity test showed that the battery was in good condition.

As the cause of failure was unknown and could happen again, the insurance company recommended that the plant contact us to see if we could determine what caused that failure, and to determine if they had other cells that could fail this way. We found a total of five more cells experiencing various stages of failure.
