bestmag
Batteries & Energy Storage Technology

Summer 2020

Avoid catastrophic failure events— Detecting internal post-seal failures due to nodular corrosion in VLA cells

The issue of internal positive post seal failures, which has been a problem issue with a number of battery manufacturers over the years, and which was understood to have been addressed and resolved quite some time ago, is now appearing again. Pete DeMar reports on his findings at three power-plant systems and explains how to detect and avoid the issue.

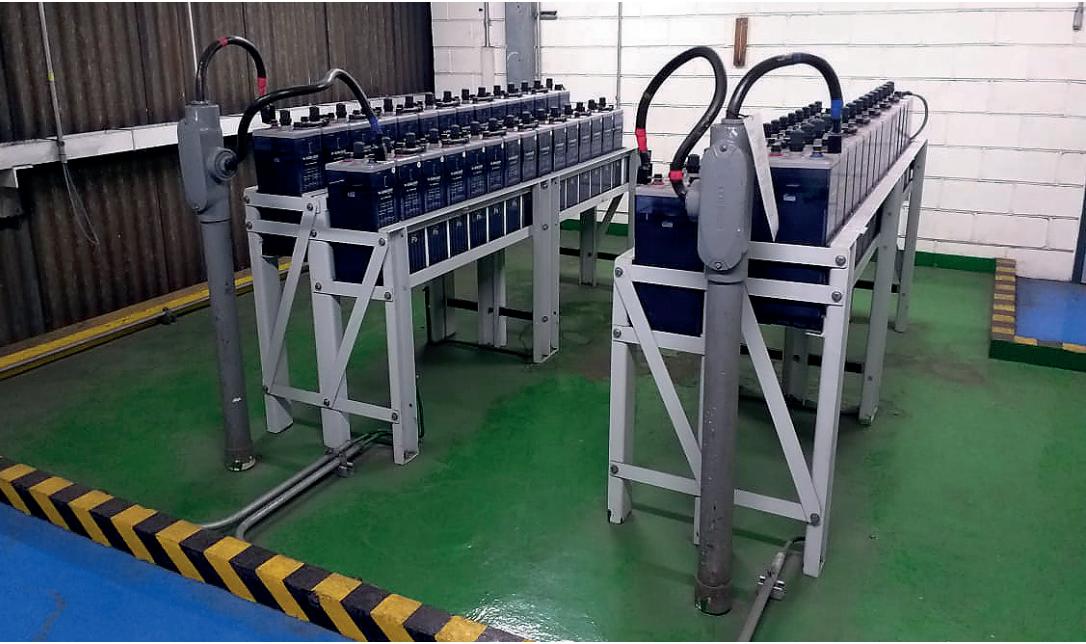
Fig 1: Initial picture received of the battery

In addition, from looking at the numerous pictures provided to us, there was nothing unusual observed. As can be seen in **Fig 1**, the battery and battery room was spotless.

The only item that was able to be observed was cell 46 had a burn mark on the inside of the jar, but nothing else was unusual. The cell was intact and showed no outward signs of a problem. Cell 46 is the cell that went open circuit when the plant transferred to battery power, which resulted in the loss of all DC support to the system.

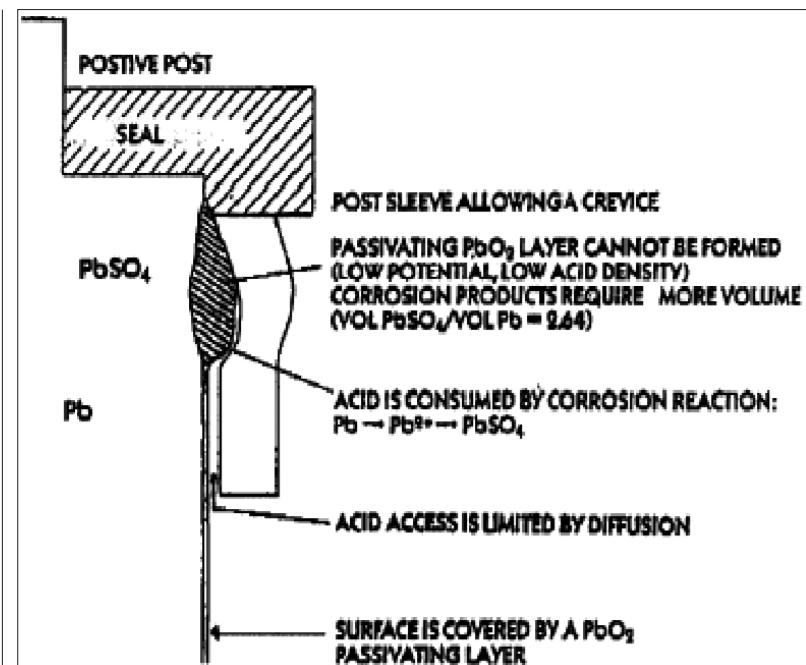
Fig 2: Drawing of nodular corrosion typical location from the INFOBAT 2004 presentation by (3) Jose Marrero of Southern Nuclear

Fig 2 illustrates how the post becomes deformed when nodular corrosion has occurred (a drawing like this is also in the paper by Brecht & Misra). They also included numerous pictures in that paper that showed cells from multiple battery manufacturers that utilised differing post-seal technologies, and each picture showed the internal positive post -seal failures due to nodular corrosion.

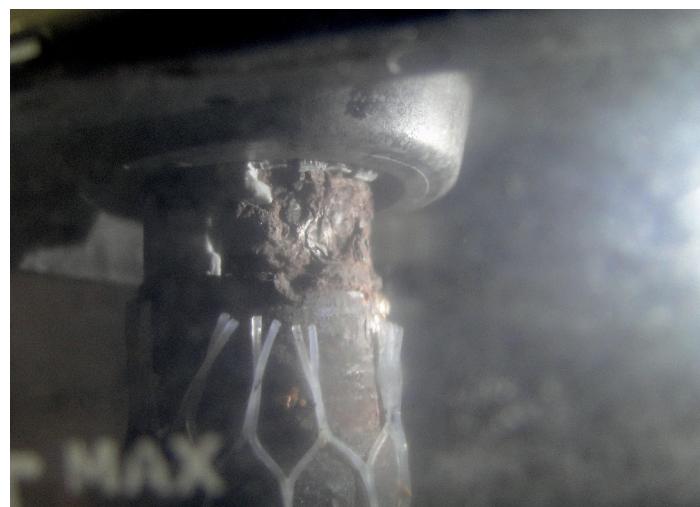
Fig 4: The brighter the light used, the easier it becomes to see some of the post seal faults

Fig 3 shows cell 51, and, as can be observed, the problem was quite advanced. **Fig 4** is the same post with brighter illumination. Through the use of the borescopes we were able to locate an additional three cells that would otherwise not have been detectable. (**Figs 5 & 6**). **Figs 3, 4, 5, & 6** are pictures taken during our on-site inspections.

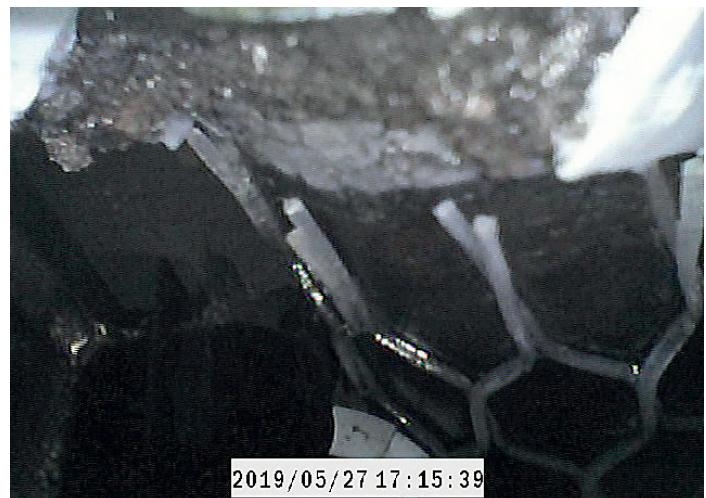
Fig 6: Borescope pic - this post seal fault was not observable from outside the cell

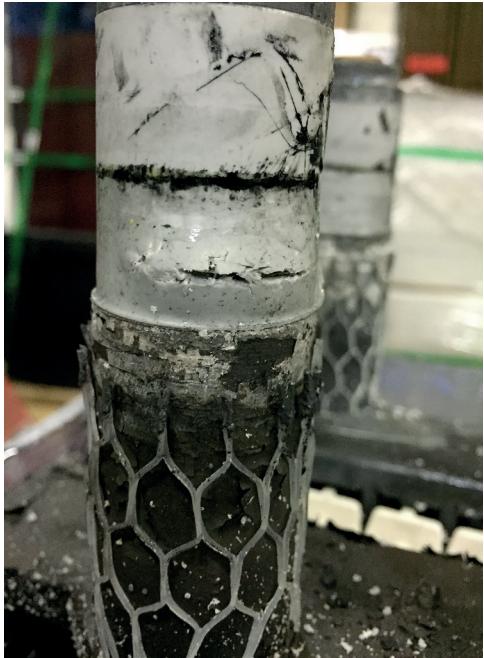
Fig 7: Cell 53 post condition on initial cut away of cover

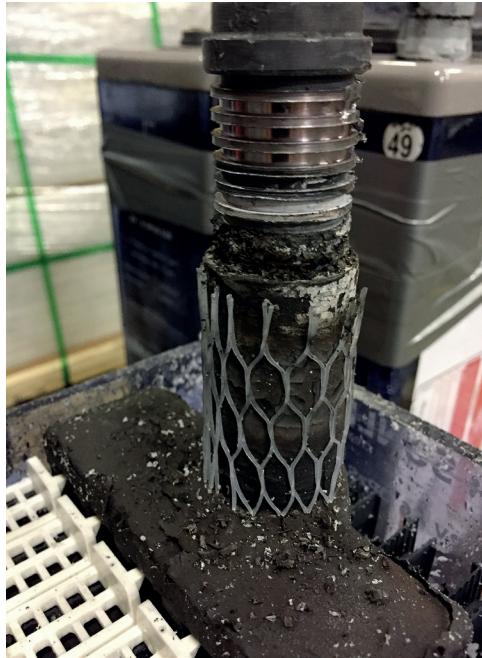
Fig 8: Condition of cell 53 post once the post-seal material was removed

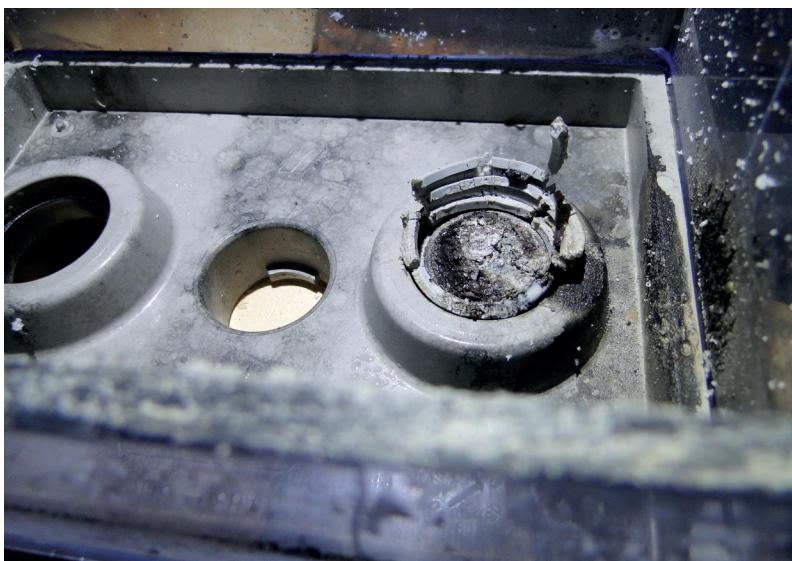
Fig 9: This is the cover from cell 46. It is easy to see the burn marks on the cover and the side of the jar plus to see that the upper portion of the post is still within its location in the cover. That this cell did not explode when the post melted apart indicates that at the time of the event, that there must have been a very low concentration of hydrogen in the head space, so no fuel was available to ignite (4). The post simply melted apart.

I consider that the decay in cell 46 could not have been acceptable just 14 months prior and rapidly deteriorated to the point where it would now fail open.

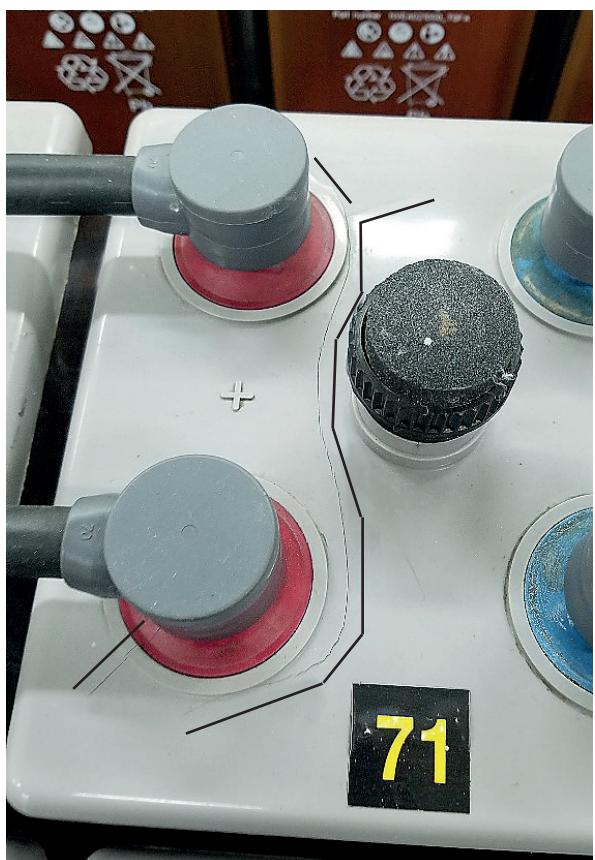
As shown in **Fig 11**, once the

nodular corrosion has advanced to some point that is specific to the cell design and materials, the covers will begin to crack. This is a direct result of the nodular corrosion. Once the cover is cracked the gasses from inside the cell will naturally seek the path of least resistance to escape the cell. These cracks in the cover obviously compromise safety as the cover will no longer have the function of a flame arrestor to prevent any outside ignition source transferring to inside the cell.

Fig 11: Cover showing results of advanced nodular corrosion

Inspection to look for these early indicators, and then to act upon your findings. We recommend that this test be performed, at least once a year, by someone

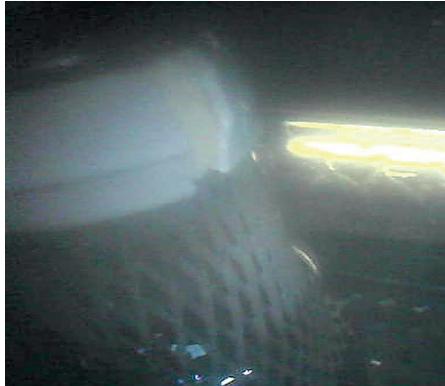
Fig 14: Different manufacturer different post seal design same issue – notice the unusual bump that is visible below the post seal level

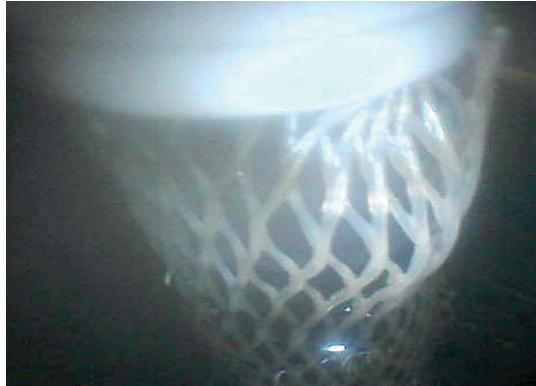
Fig 15: Unusual bump below the webbing, but no evidence of a post seal failure yet
