## Nodular corrosion: detecting the hidden problem

# Nodular corrosion – detecting the hidden problem

With nodular corrosion ignorance is not bliss – it is just ignorance. Pete DeMar, founder of Battery Research and Testing, explains how to detect nodular corrosion in your lead-acid battery positive posts years before it puts your system at risk. This applies to all vented lead-acid (VLA) batteries, with particular application to high-inrush loads such as found in UPS and power plants.

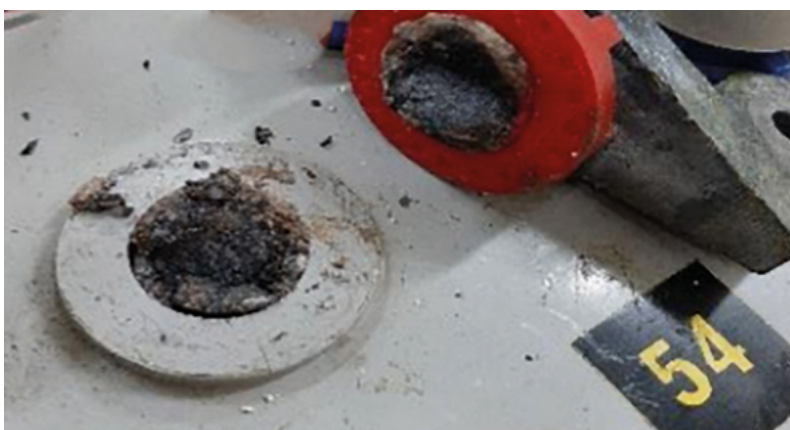
*Fig 2: Positive post that melted apart*

Fig 2 shows the positive post that melted apart when the power plant tripped and the battery was called upon. This investigation was reported in the

2020 article. This picture was taken once we removed the cover so that we could closely study the post. The damage to the generator required months to be repaired and placed back into service. The losses were in the millions of dollars. This cell did not explode when it opened, it just melted apart. The gas mixture in the headspace was not the correct ratio to cause an explosion.

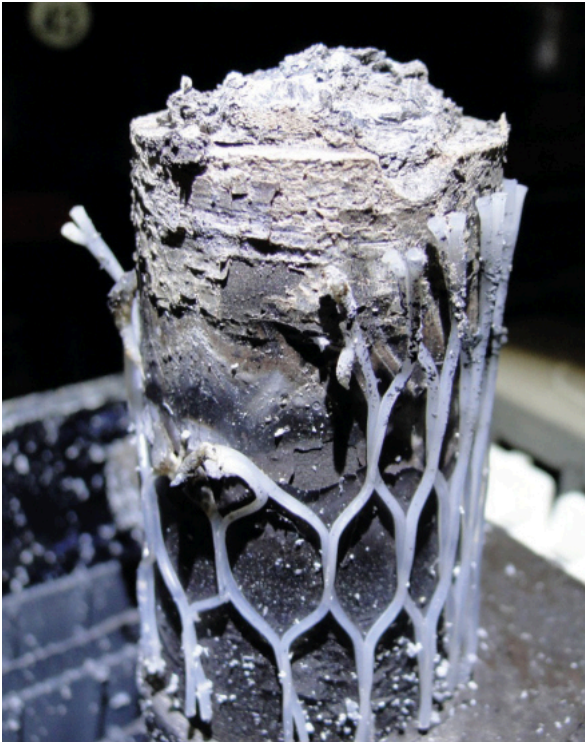
*Fig 3: Cell that exploded when right rear positive post opened*

**Fig 3** shows a cell in a medium-size battery at a power plant – the battery was off-line for testing. As can be seen, the cell exploded when the right rear positive post opened during the test – which meant that the gas mixture supported ignition, and this was the result. If this unit had tripped when the battery had been in service, the result would have been the loss of millions of dollars to the power plant.

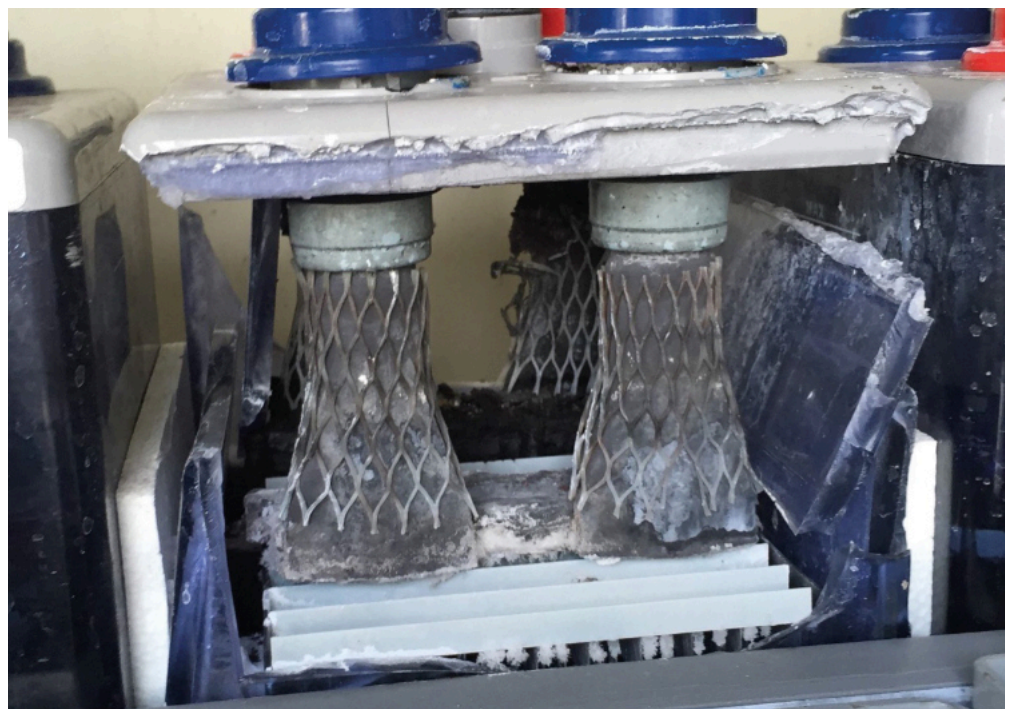
*Fig 4: positive post that melted apart during the inrush part of testing*

**Fig 4** shows a cell from a large amp-hour battery at a power plant. This battery was offline being tested – to verify that it could support the site loads if called upon – and this shows what happened. One of the two positive posts melted apart during the inrush part of the test. It is possible that if the user had not been performing a service test, and just performed a standard performance test, that the battery, which had passed previous tests, might have passed its test again.

This is exactly why it is important to perform all discharge tests at rates that encompass the actual required loads. This plant's loss, if it had occurred when the battery was online, would have been in many millions of dollars.
