Date: 12/15/2025

To: Document Control Desk
U.S. Nuclear Regulatory Commission
Washington, DC 20555
Fax Number (301) 816-5151

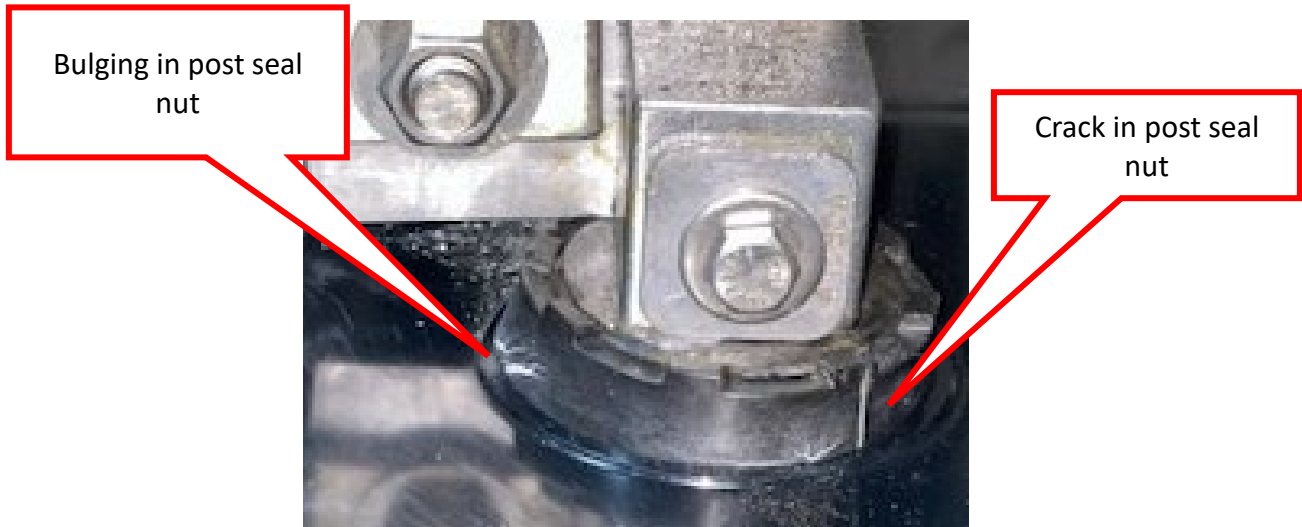
Positive Post Corrosion Indications – Figures 1 thru 4 below provide visual indicators of corrosion in the post seal area.
