A PRIMER ON NODULAR CORROSION IN STATIONARY LEAD-ACID BATTERIES

Peter DeMar
Battery Research and Testing Inc.
Oswego, NY 13126
315-342-2373

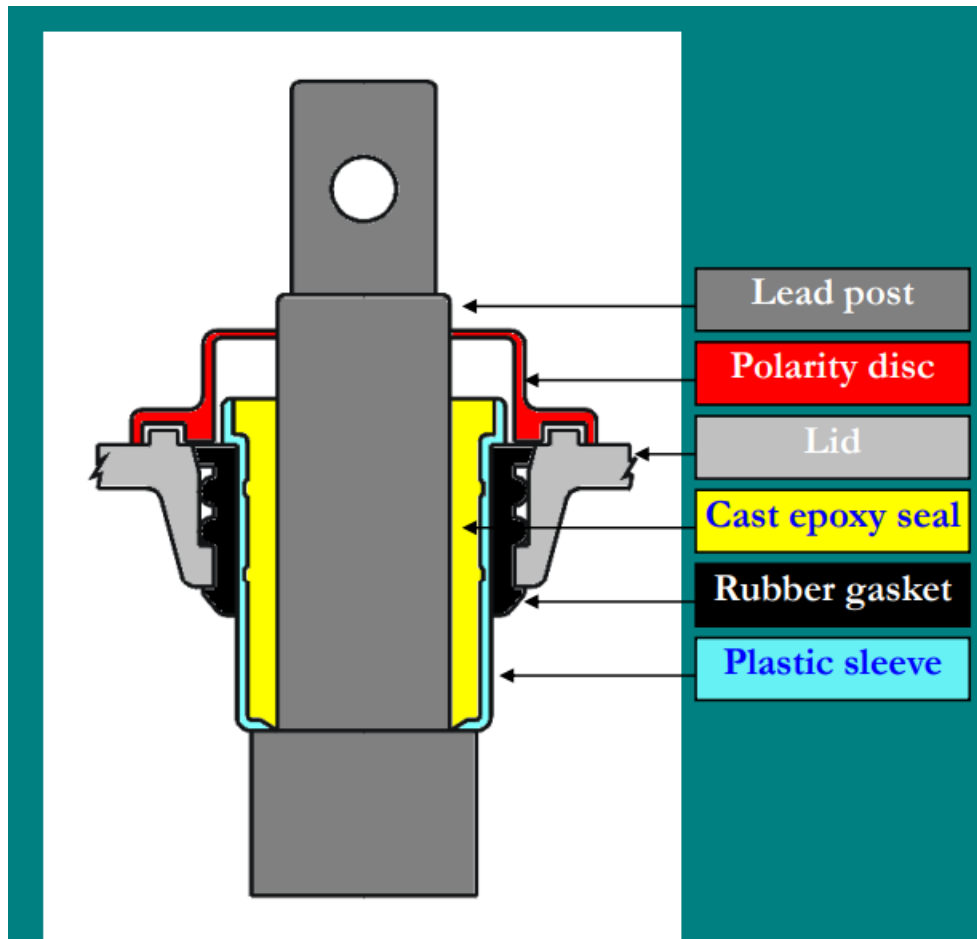
Figure 1: a typical epoxy type post seal design

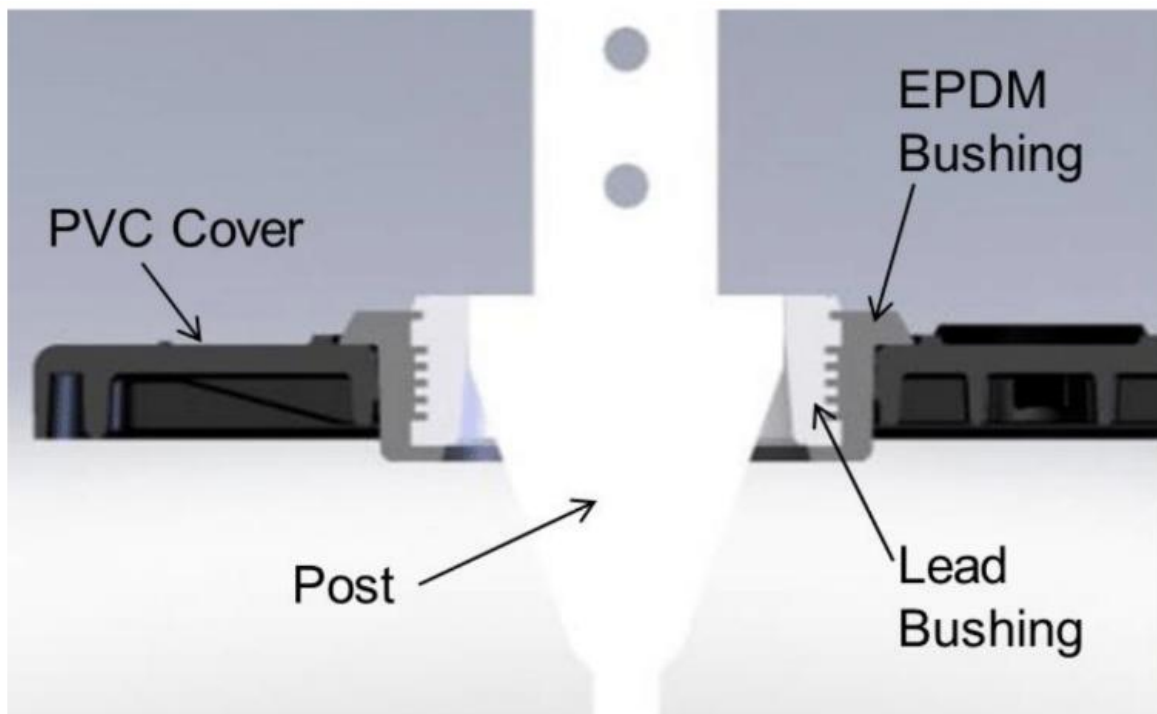
Figure 3: a typical vulcanized rubber post seal design

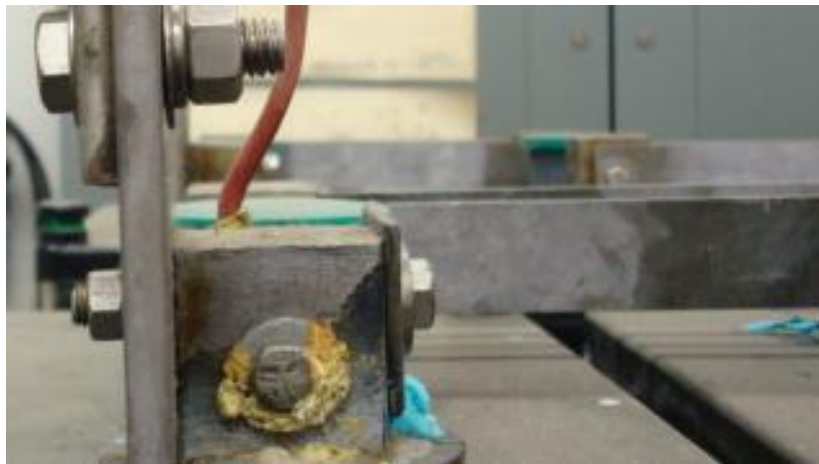
Figure 4 creep corrosion

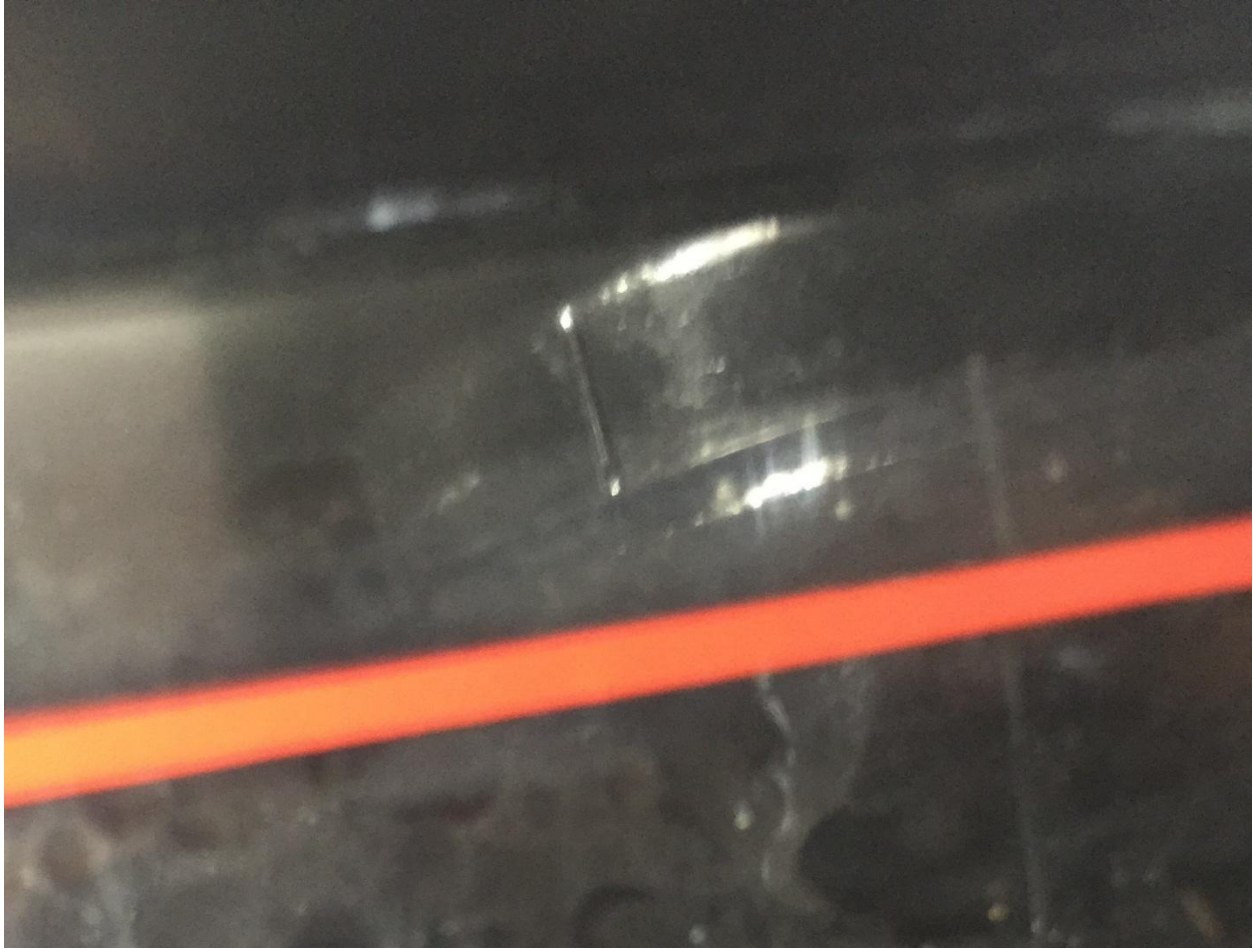
Figure 5 early detection of a crack in the post seal well wall through jar wall capture

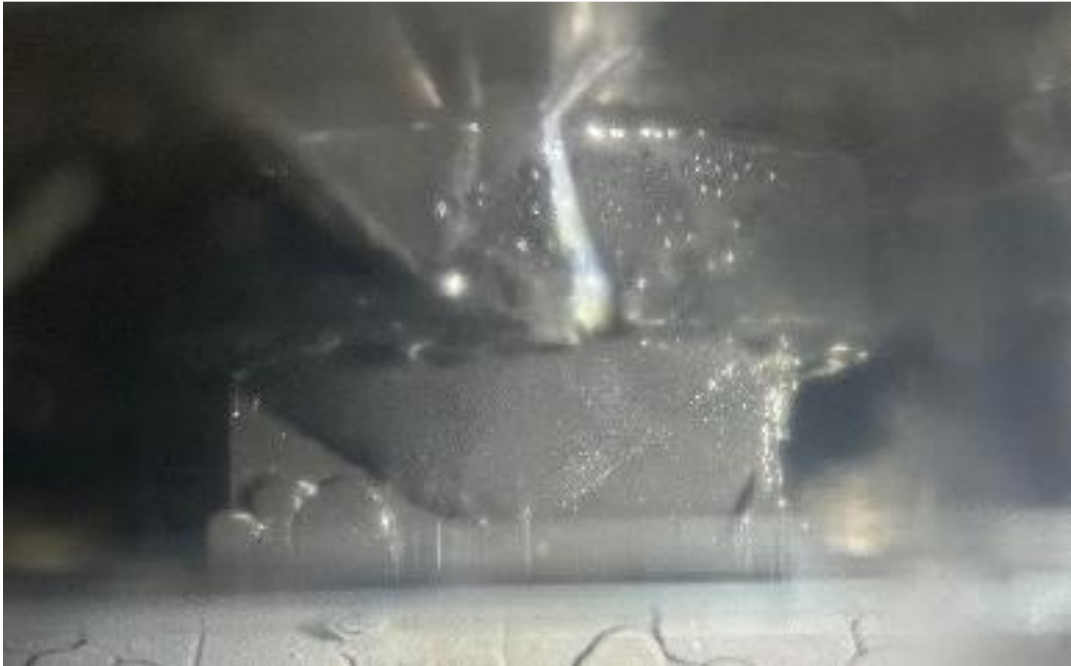
Figure 6 crack in the side of positive post seal well wall

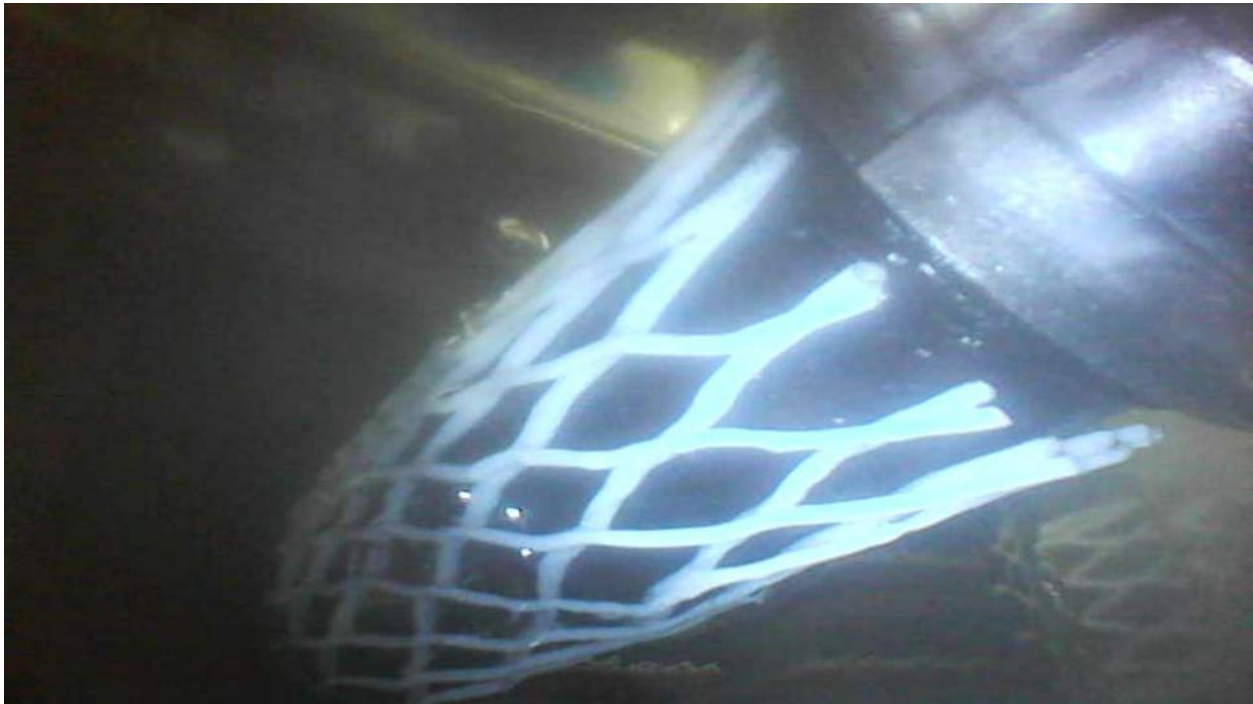
Figure 7 beginning of a crack in the side of positive post seal well wall

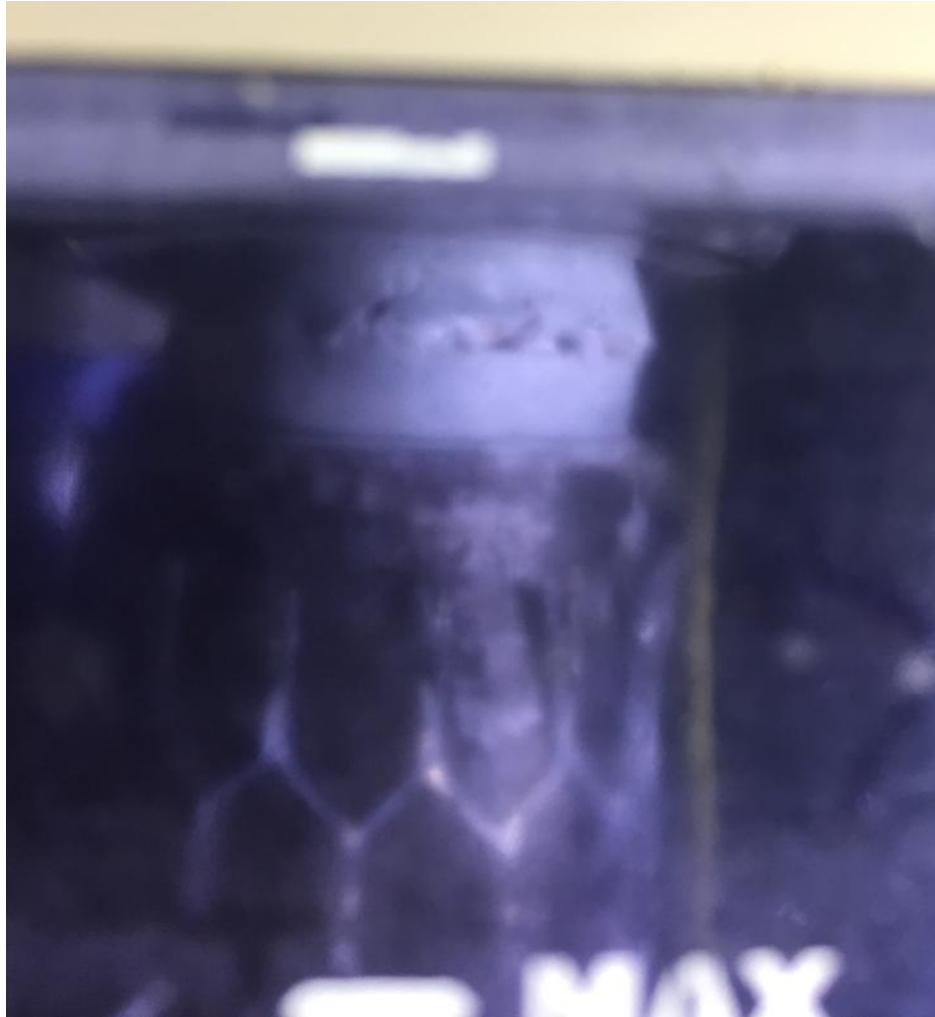
Figure 8 advanced expansion under plastic and post degradation viewed through jar wall

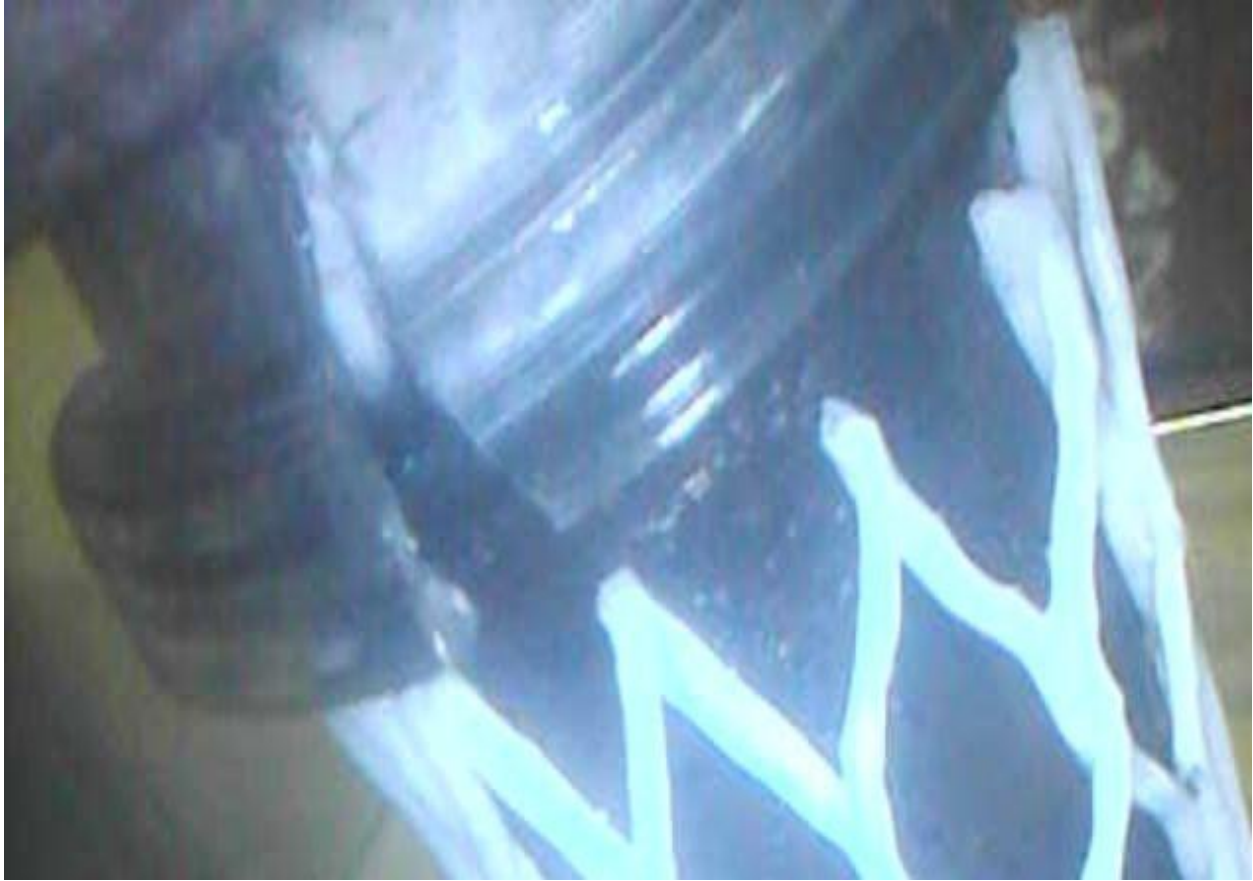
Figure 9 early stages of plastic rupturing due to post expansion borescope capture

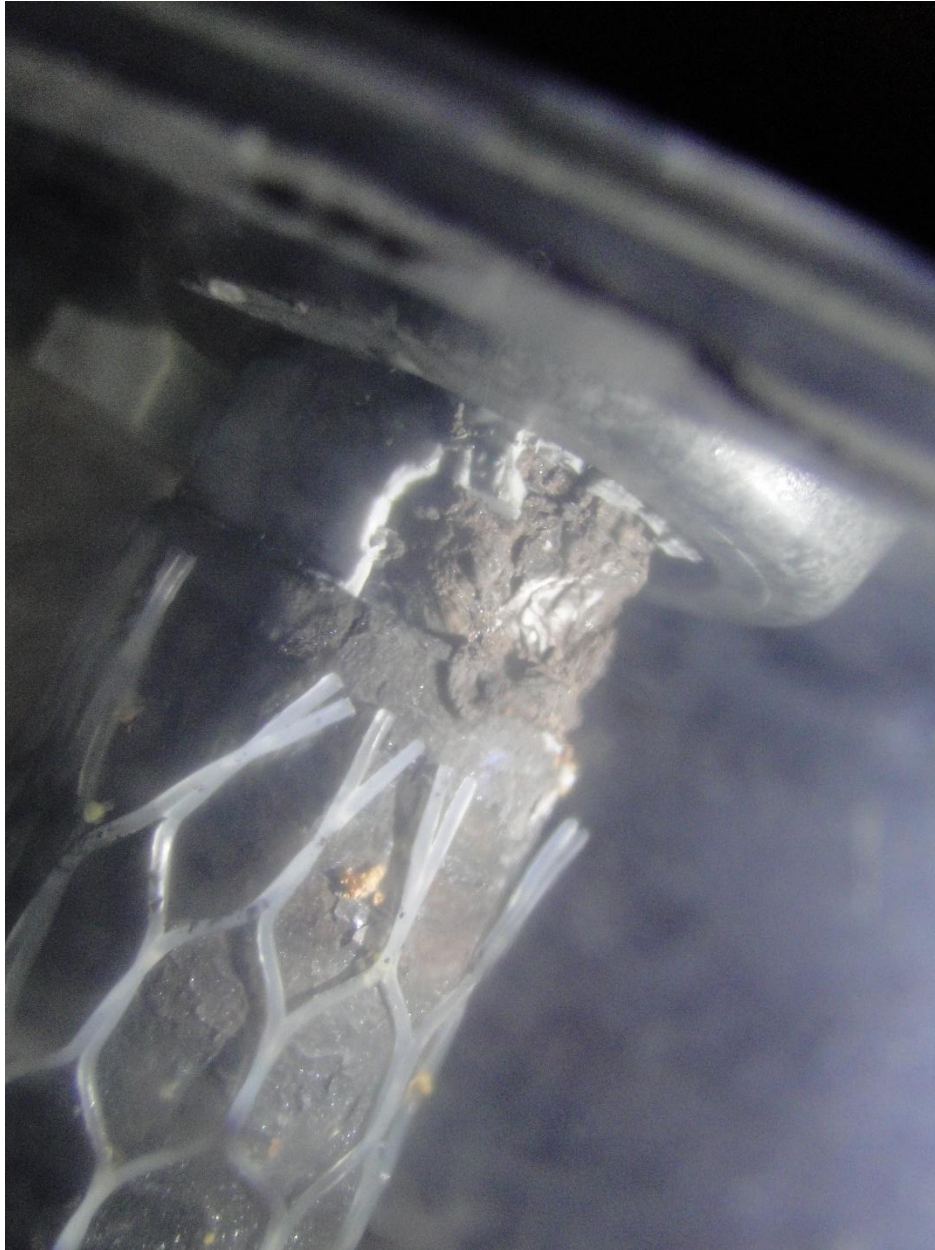
Figure 11 medium stage of nodular corrosion decay on rear side of post viewed with borescope. The plastic material that had been broken off was observed in the electrolyte.

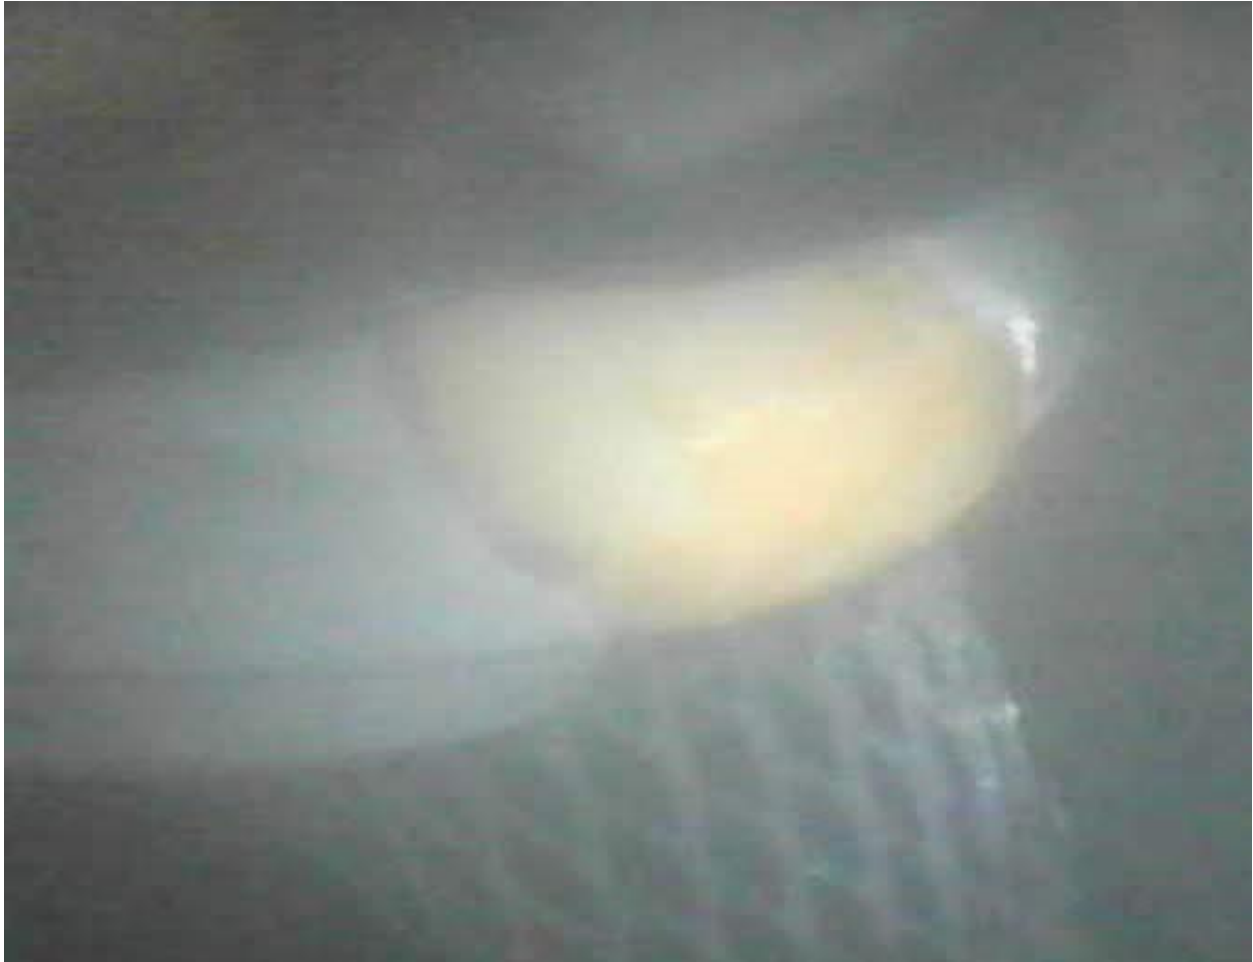
Figure 12 advanced stage of expansion through jar wall capture

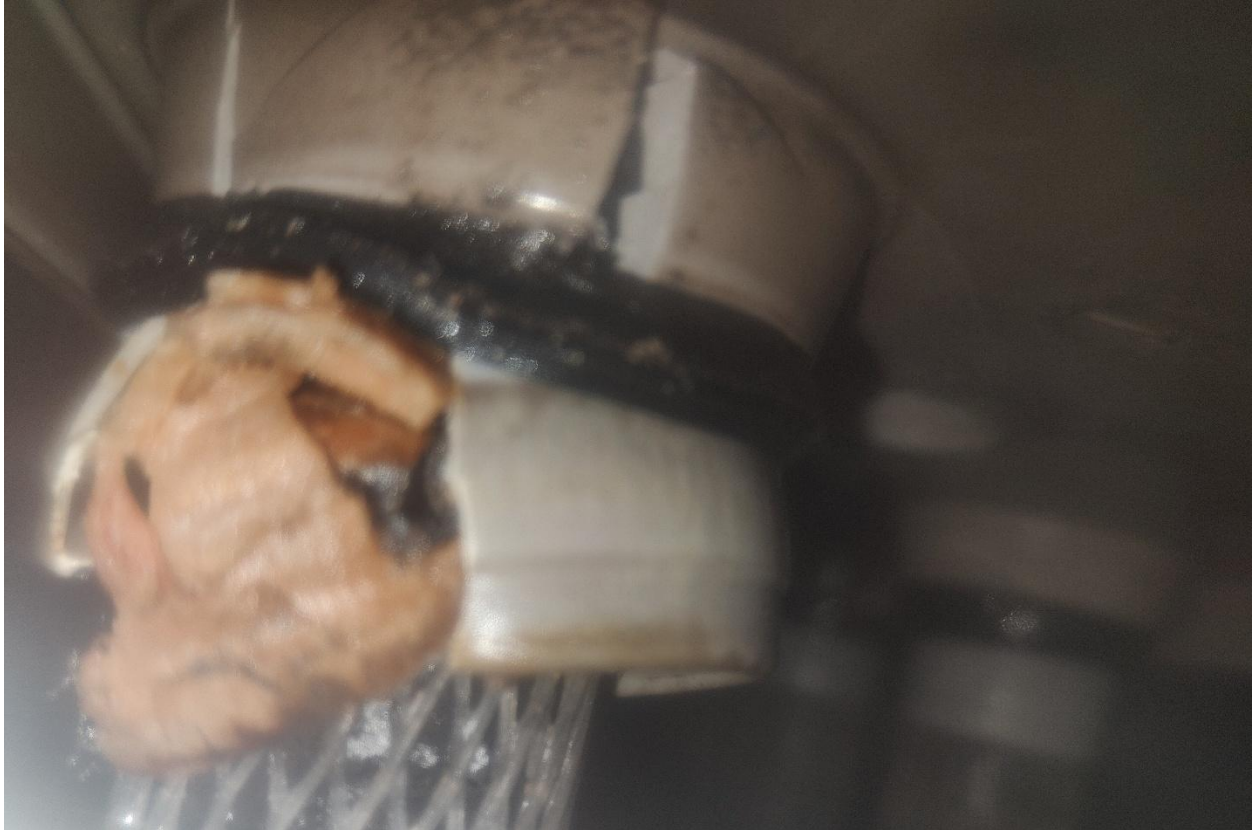
Figure 13 very advanced stage of degradation through jar wall capture – broken off plastic material was in electrolyte.

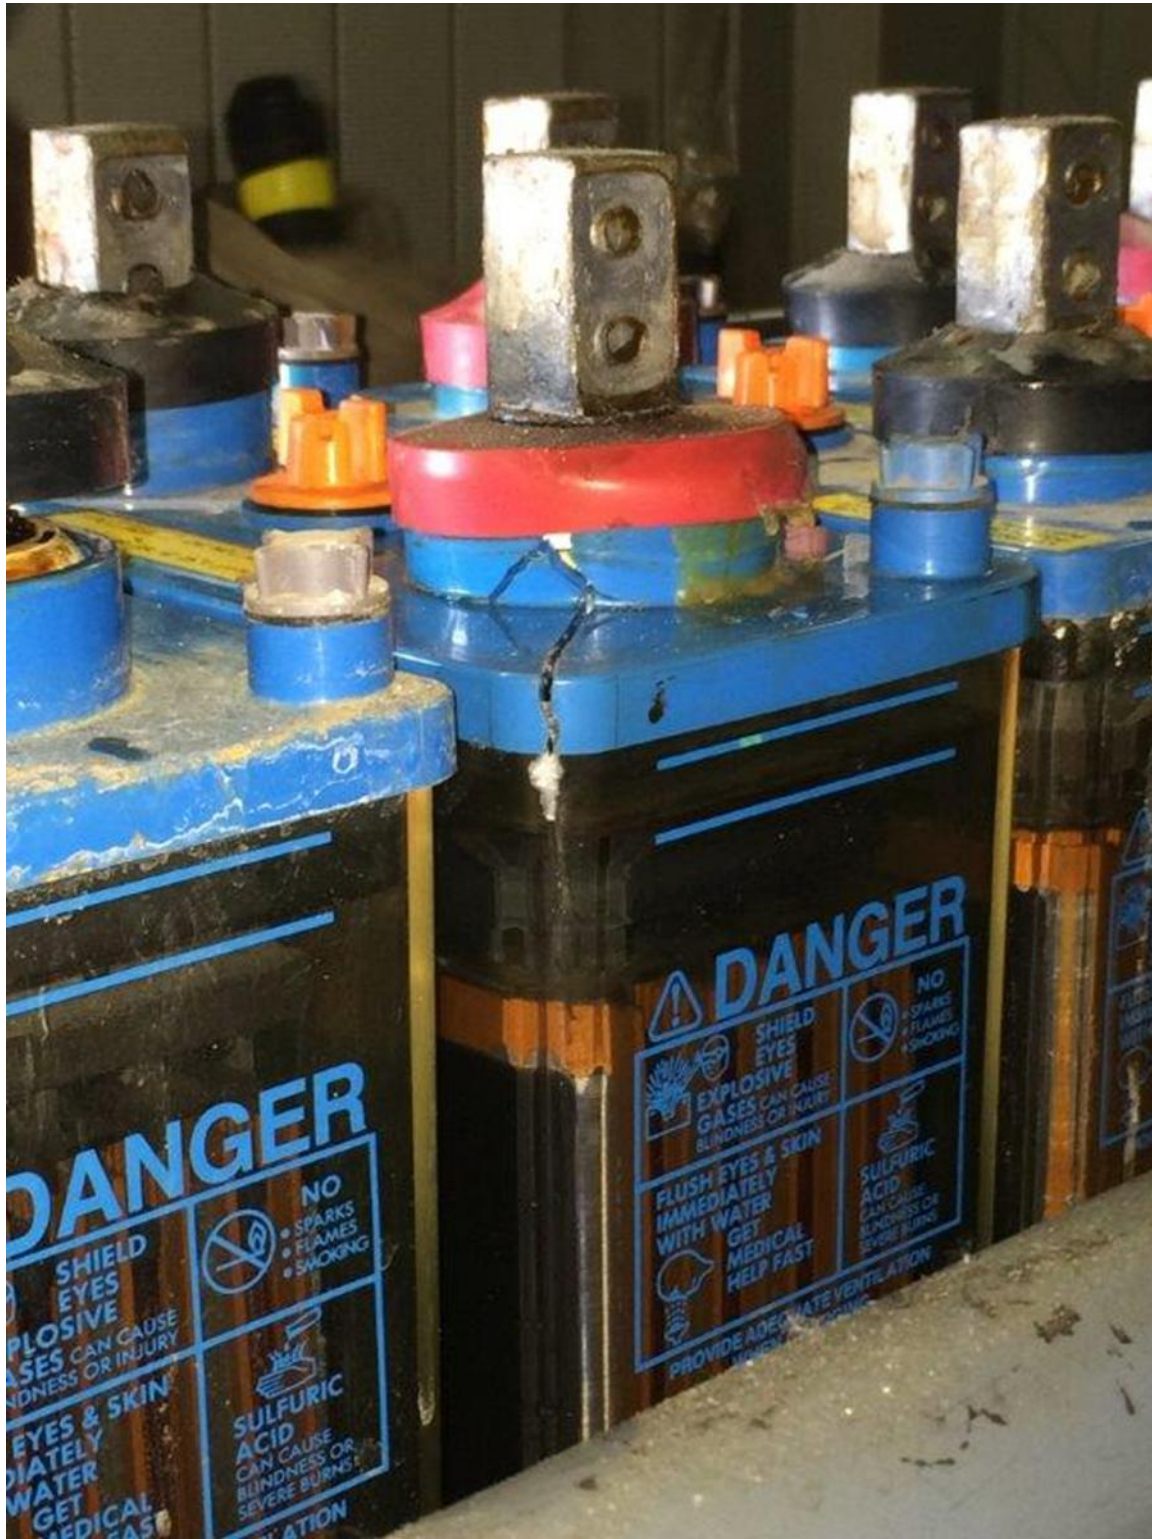
Figure 14 both creep corrosion and cover cracking due to nodular corrosion

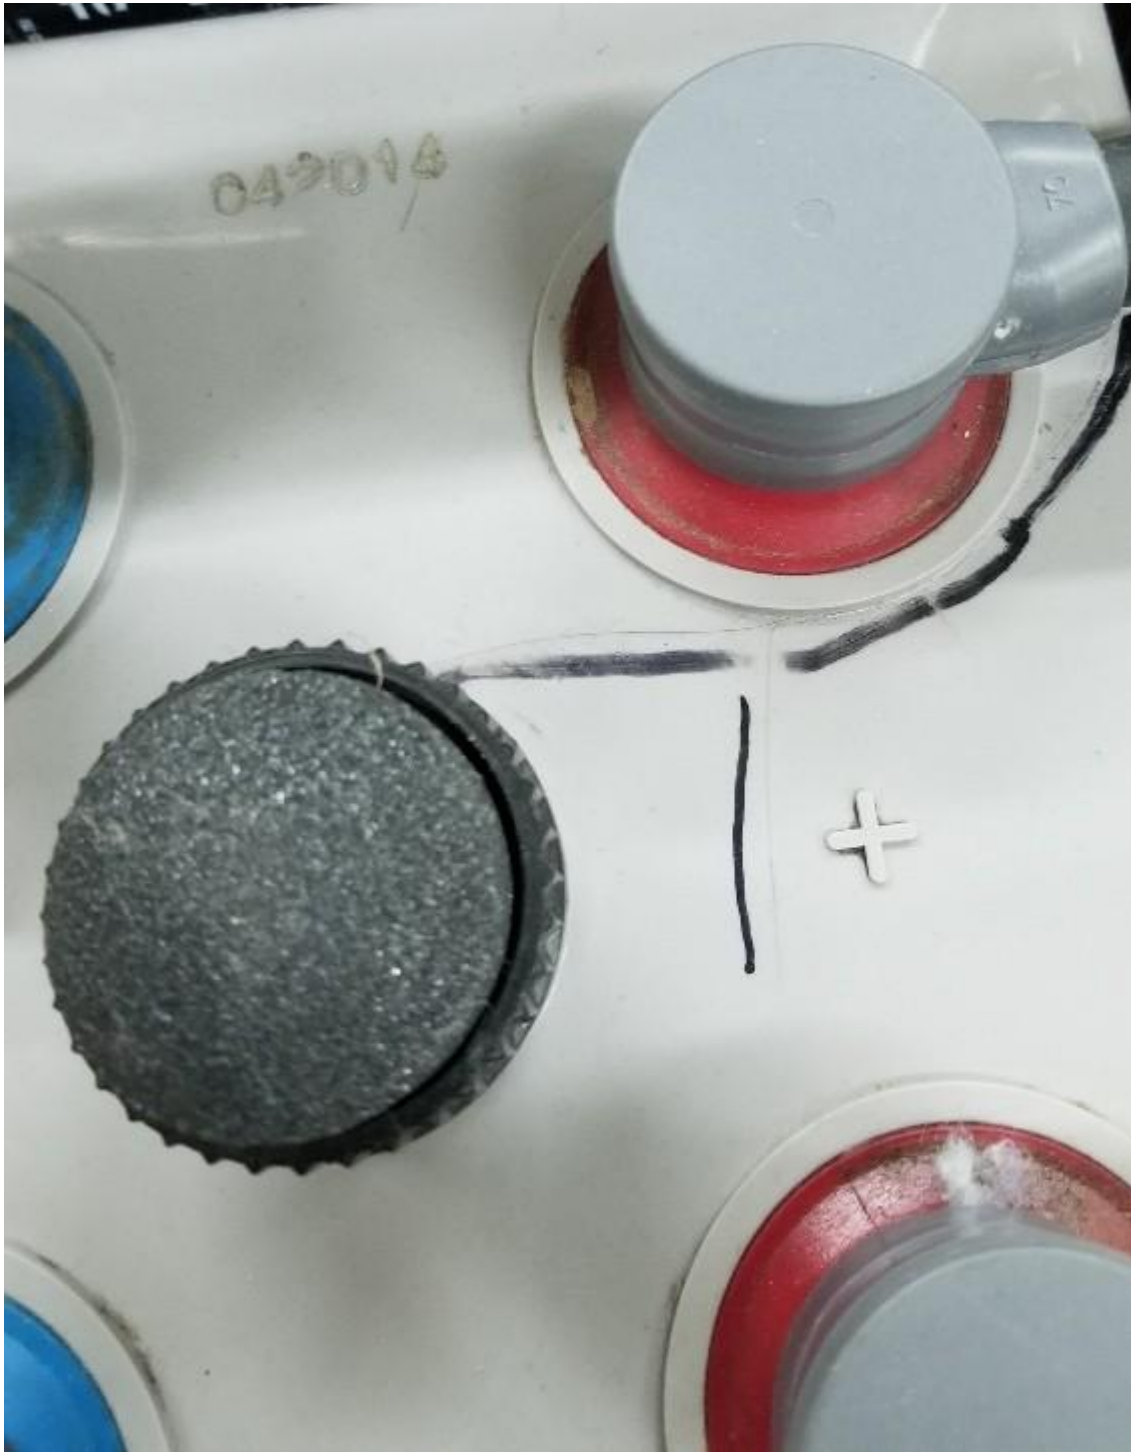
Figure 15 cover cracking proof of nodular corrosion presence

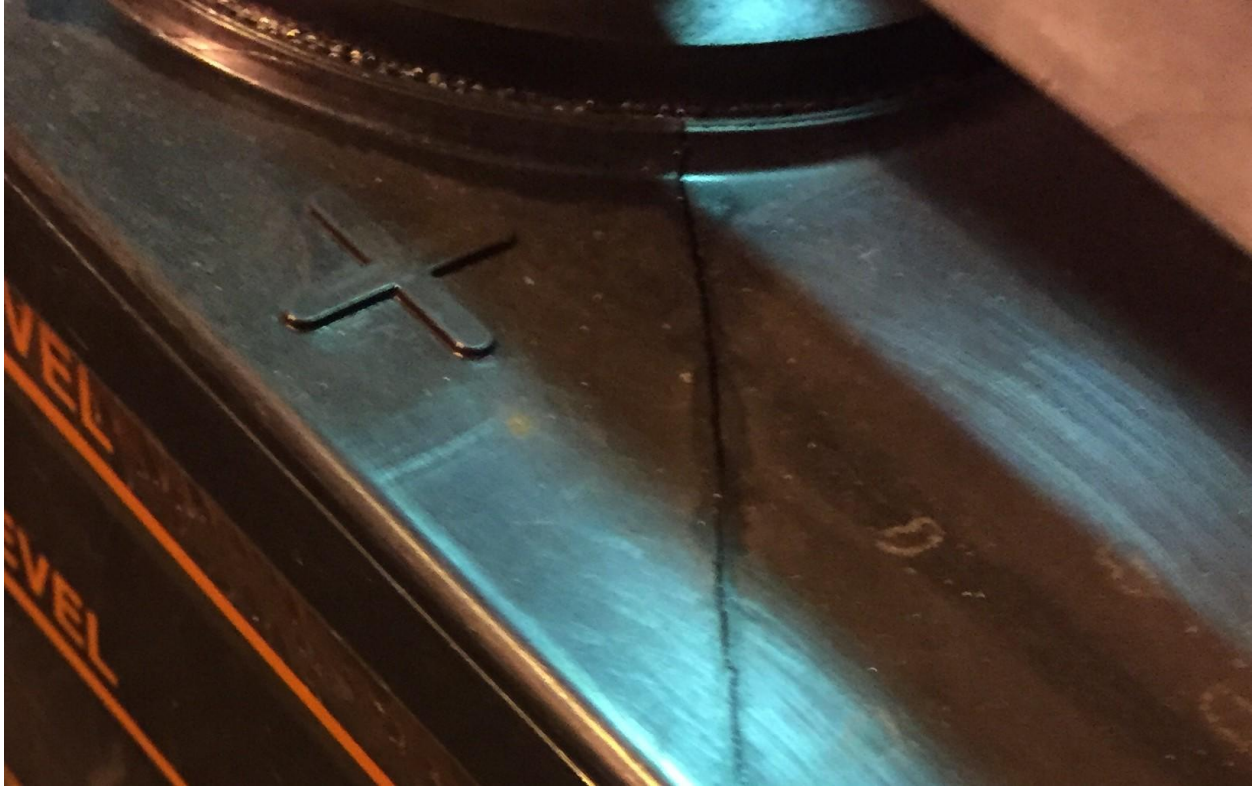
Figure 16 cover cracking radiating away from positive post indicates nodular corrosion presence

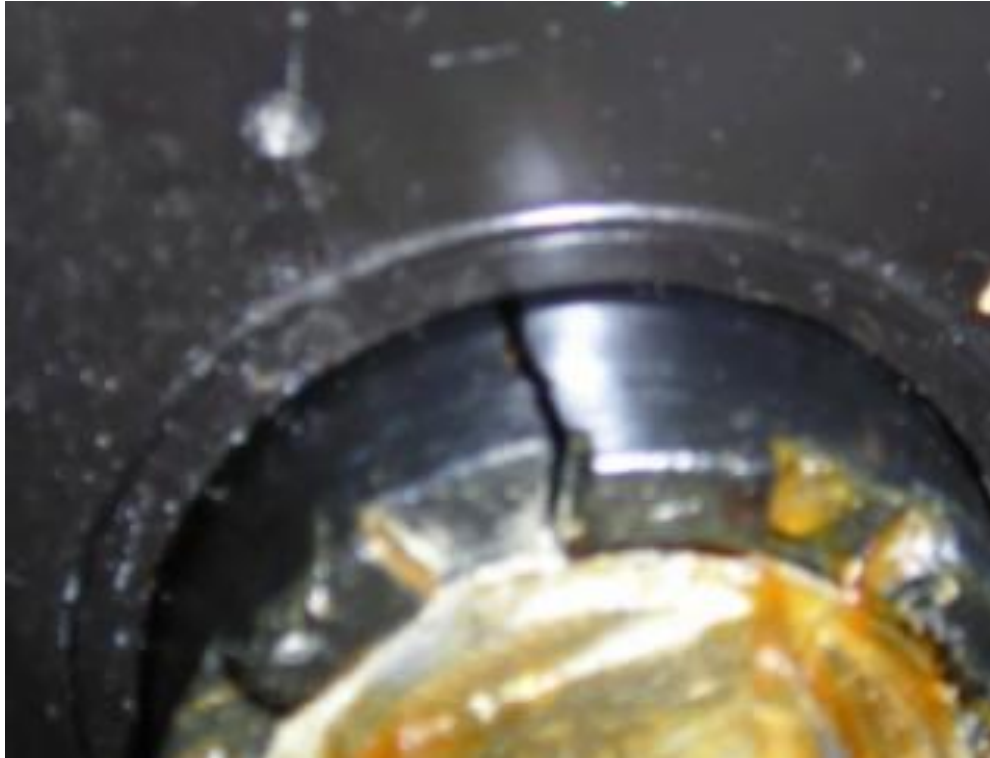
Figure 17 a positive post compression seal nut cracking proof of nodular corrosion presence

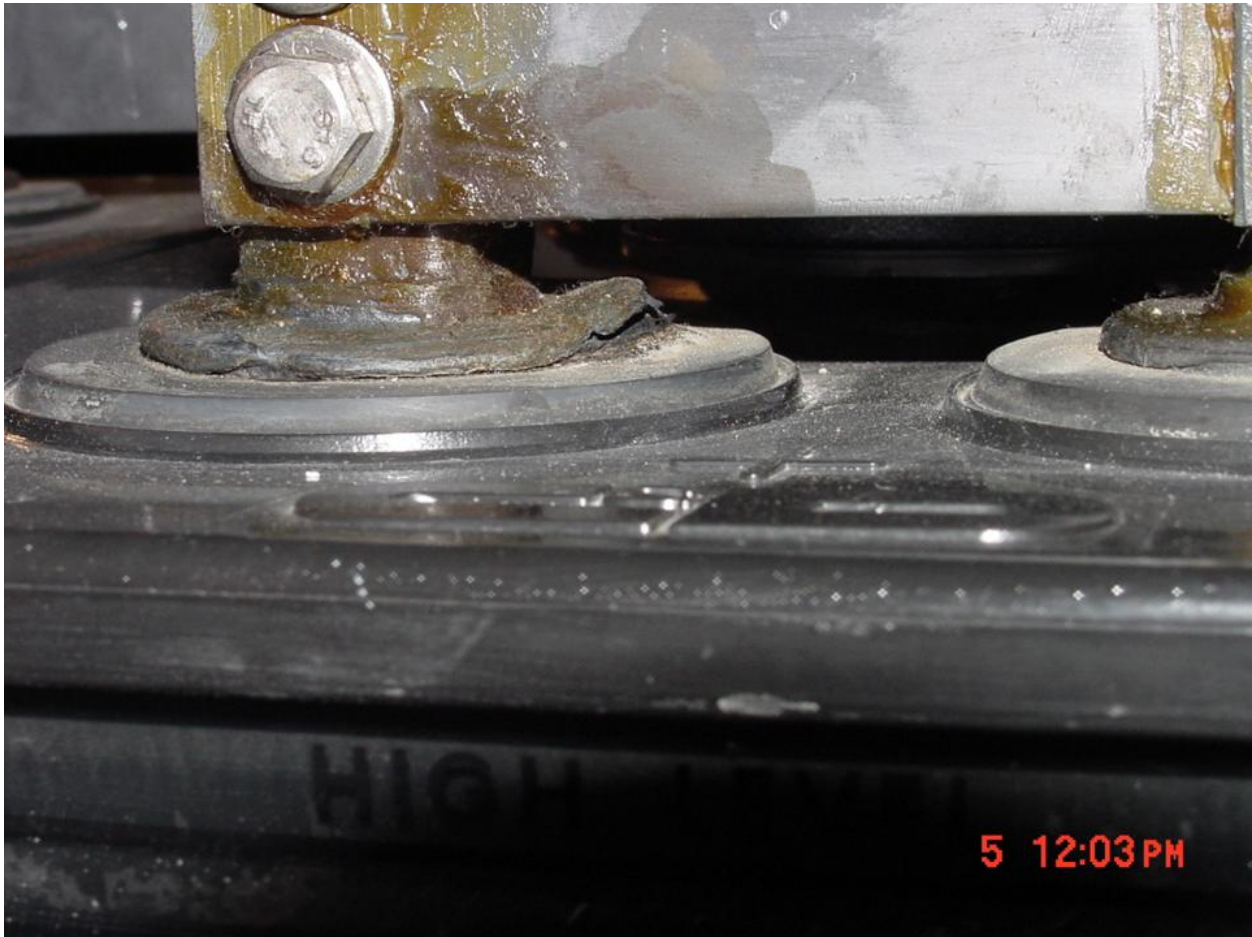
Figure 18 Blackening of positive post, creep corrosion, and edge of the post seal bushing being turned upward are all indicators that nodular corrosion is present.

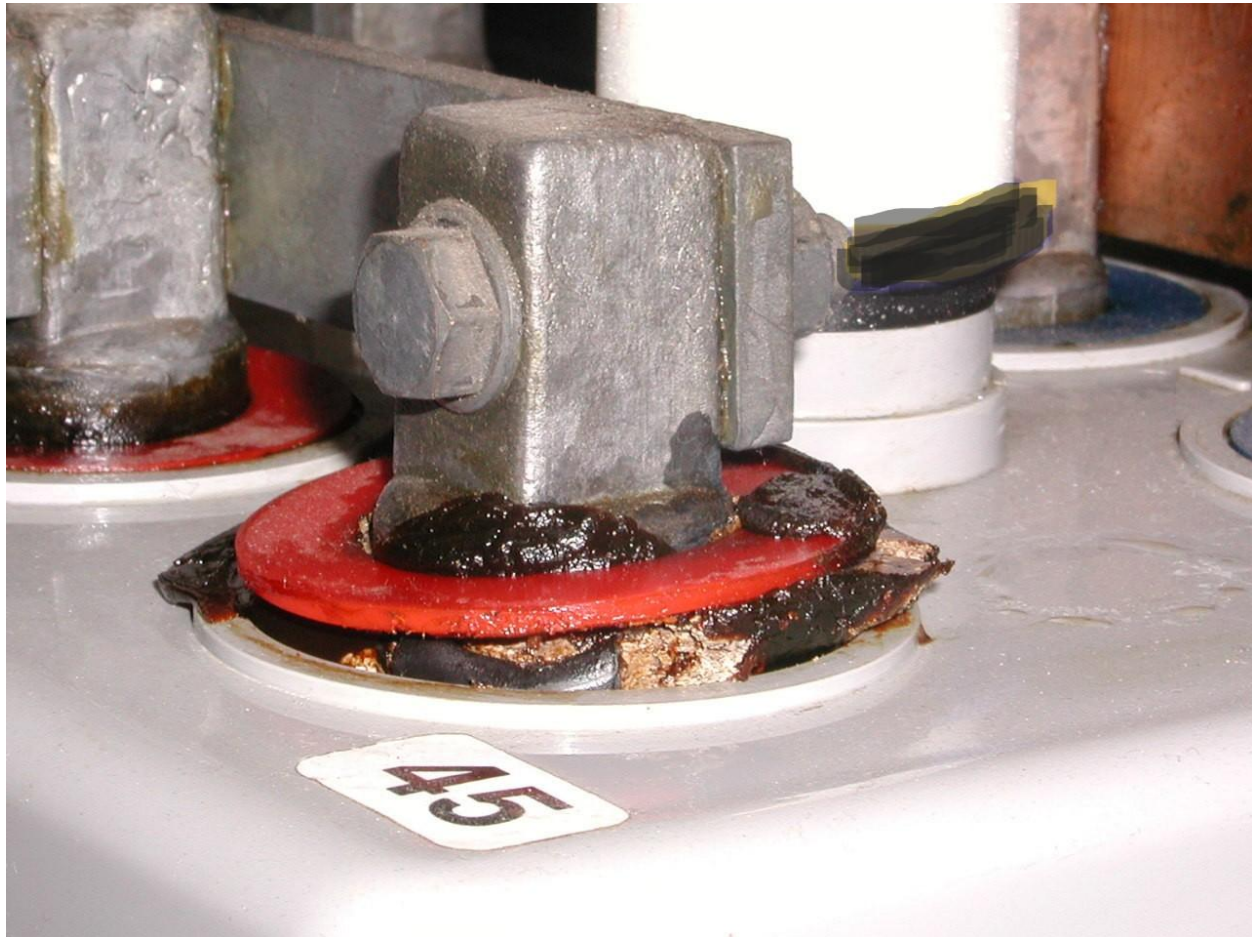
Figure 19 slight creep corrosion on both posts and advanced nodular corrosion in one

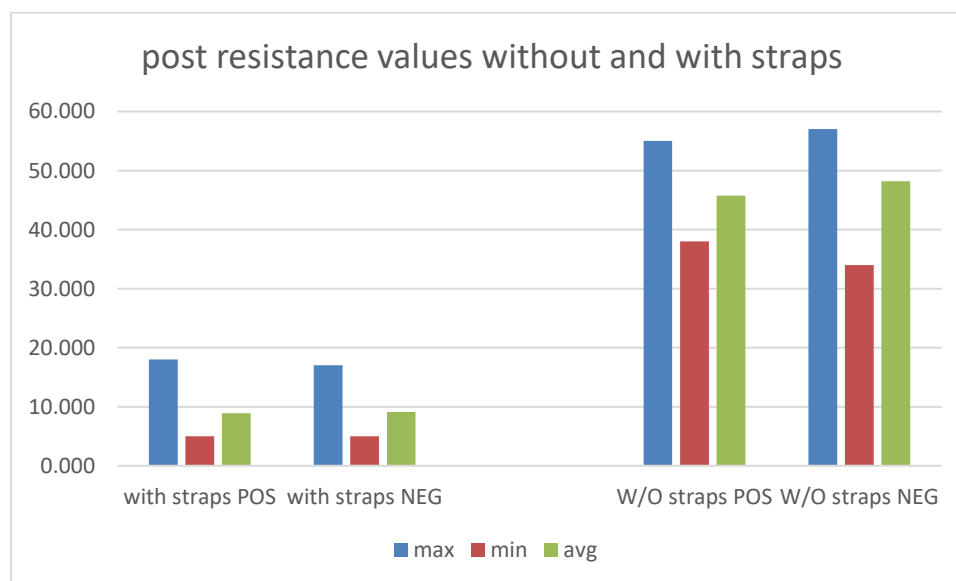
Figure 20 different post(s) microohm resistance results from performing a Nodular Corrosion Detection inspection incorrectly and performing it correctly (clue with straps is incorrect).

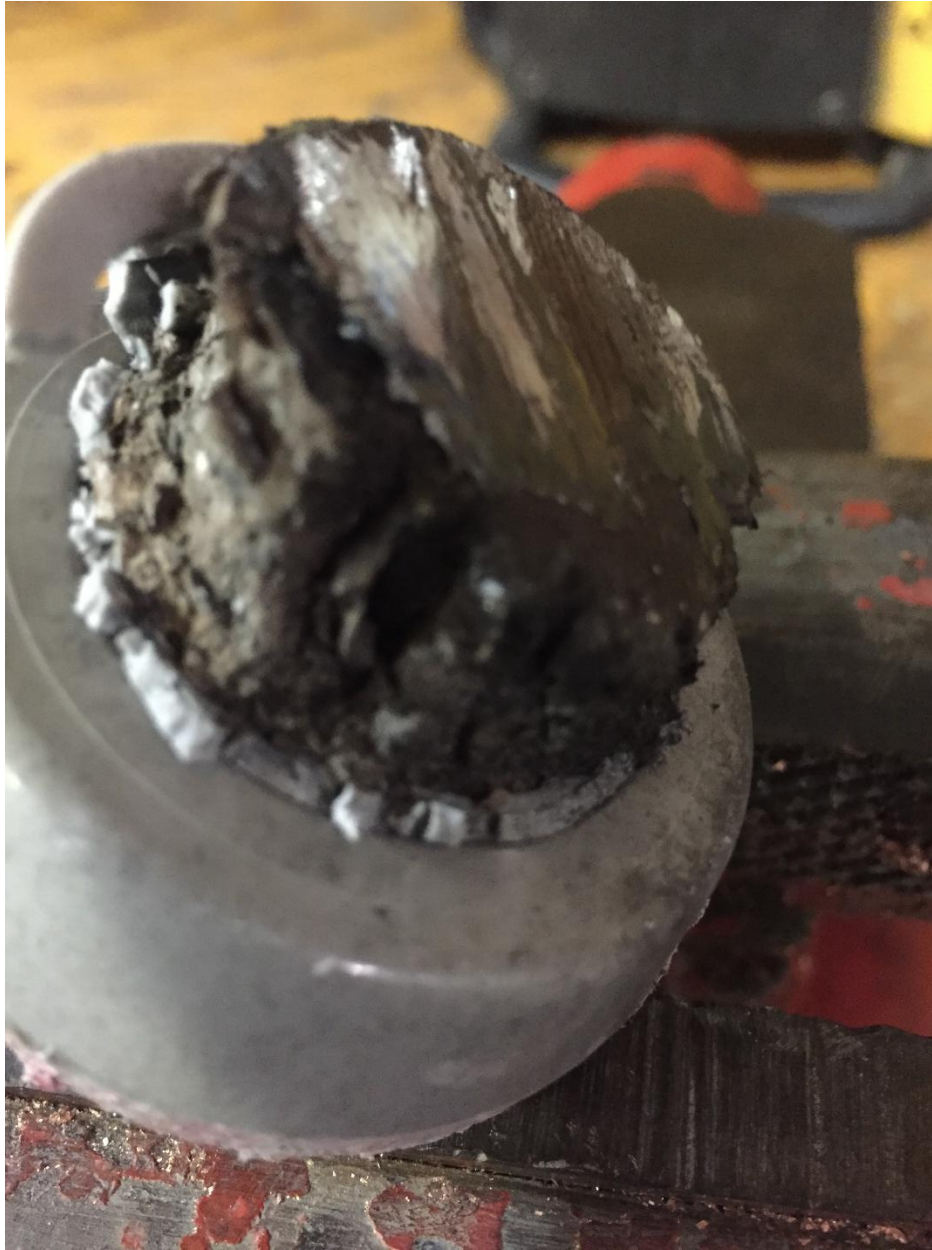
Figure 21 shows the type and degree of degradation that had occurred in this post at the time of dissection. We cut this post off from the plates so that we could more closely examine how the post was being degraded.

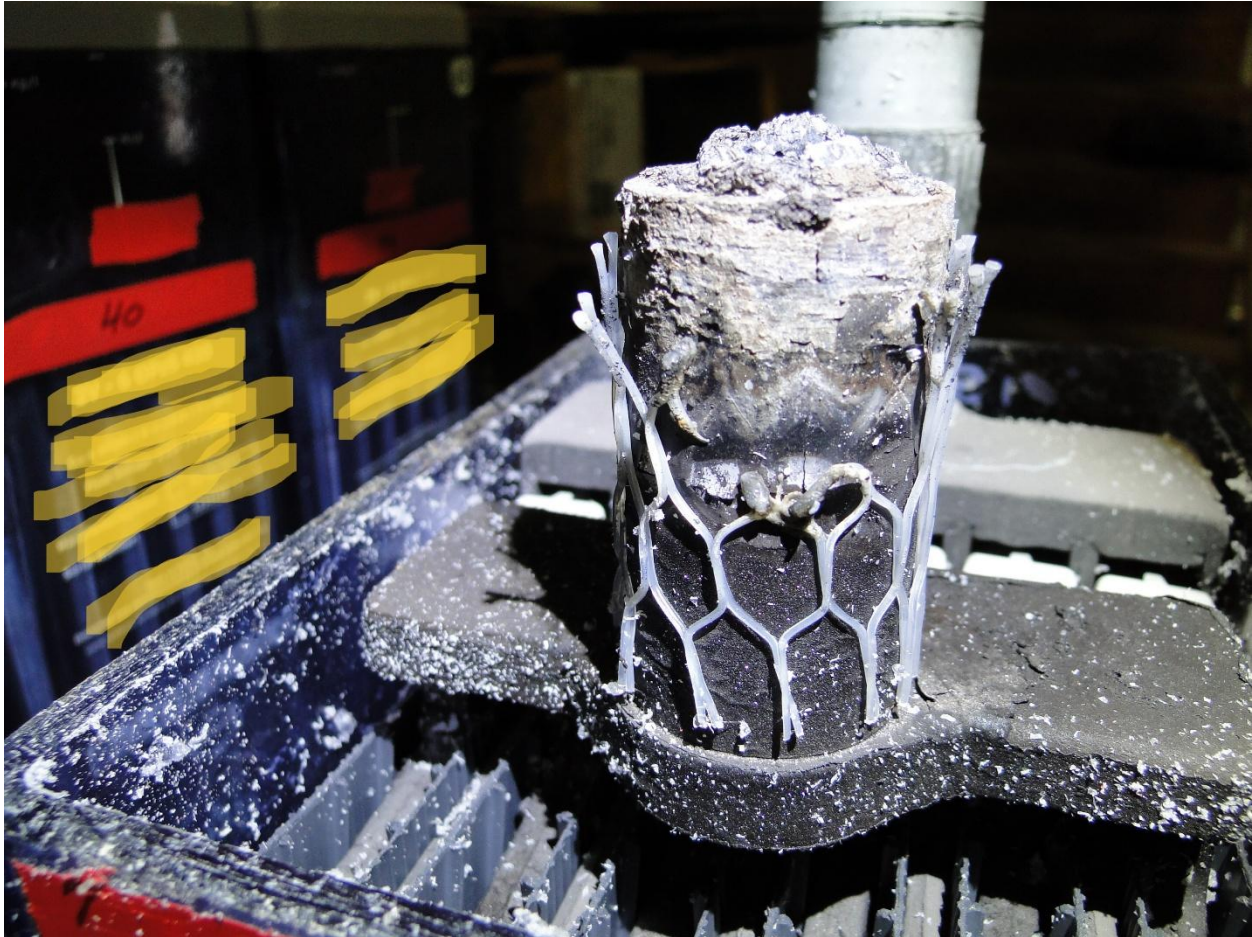
Figure 22 shows the positive post that melted apart when the power plant that it was supporting tripped offline. The battery failed open as soon as the inrush loads were applied. This battery had PASSED a capacity test at its published three-hour rate just 14 months prior to this event, and this cell was not the weakest cell in the battery string. It passed the test with over 100% capacity. The cell did not explode. This failure caused damage to the generator which took months to rebuild, and cost millions in repair costs and lost revenue.

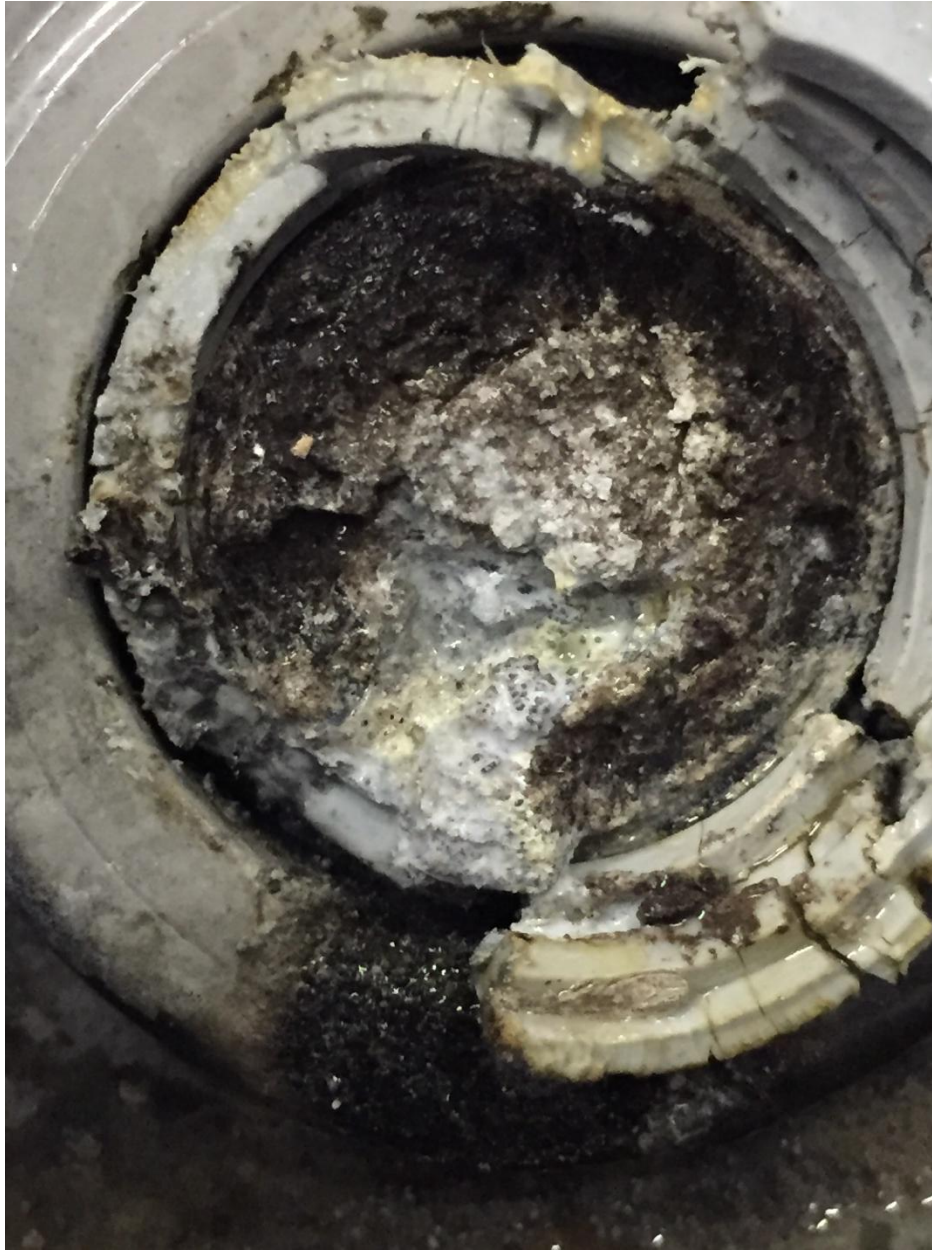
Figure 23 is a closeup of the upper portion of the post from the previous picture. This is within the post seal well. As can be seen the metallic structure has undergone severe change. This post melted open but the cell did not explode.
