A PRIMER ON NODULAR CORROSION IN STATIONARY LEAD-ACID BATTERIES

Peter DeMar
Battery Research and Testing Inc.
Oswego, NY 13126
315-342-2373

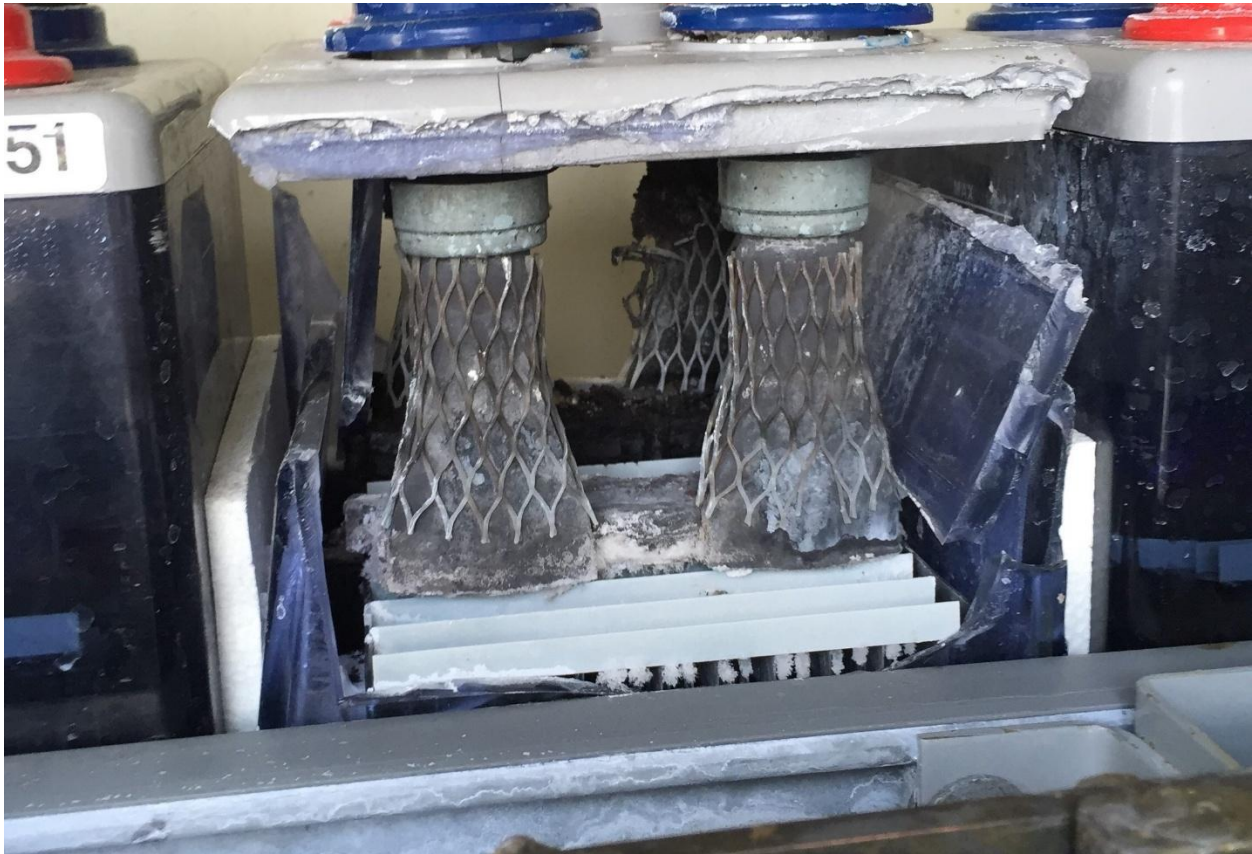
Figure 24 shows a cell that exploded during an offline discharge test due to nodular corrosion in the right rear positive post causing that post to open. Lucky for this user this occurred when it was offline as if it had been online with the generator running, the generator would have been damaged with the resulting costs and lost revenue.

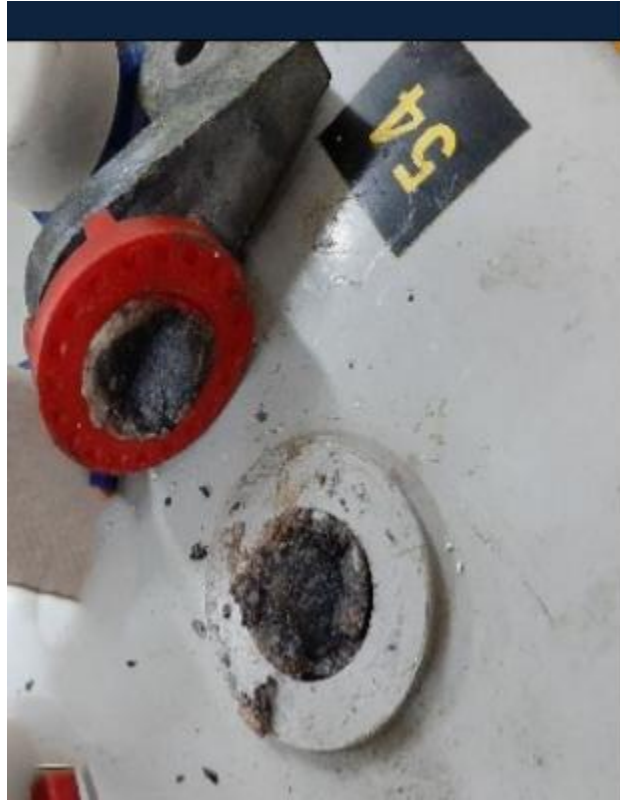
Figure 25 is the positive post in a very small cell that melted apart under its load. I previously identified this as a fragility issue and the result of “torque’ checking of the connection, but upon further study realized that it was a separation under load.

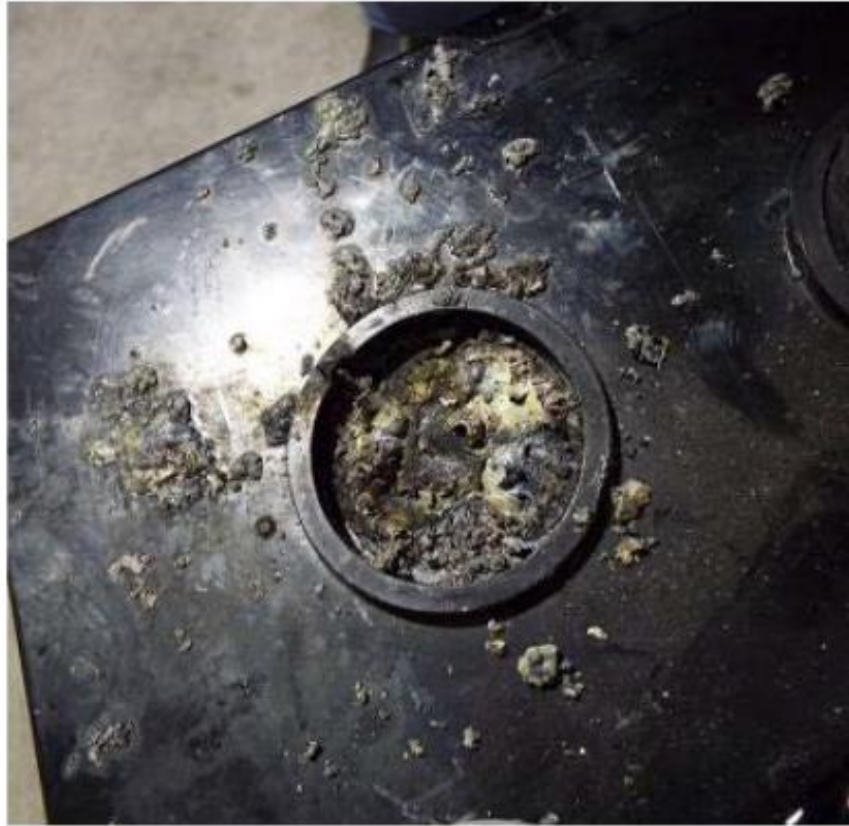
Figure 26 shows the lower portion area of this post that melted apart when the load was applied. This occurred when the string was out of service and was undergoing a service test. As can be seen, this separation is within the post seal well. The upper portion of the post was still connected to the connection hardware. The cell did not explode. This plant also dodged the bullet because if it had been online and it caused damage to the generator the losses again would have been substantial.

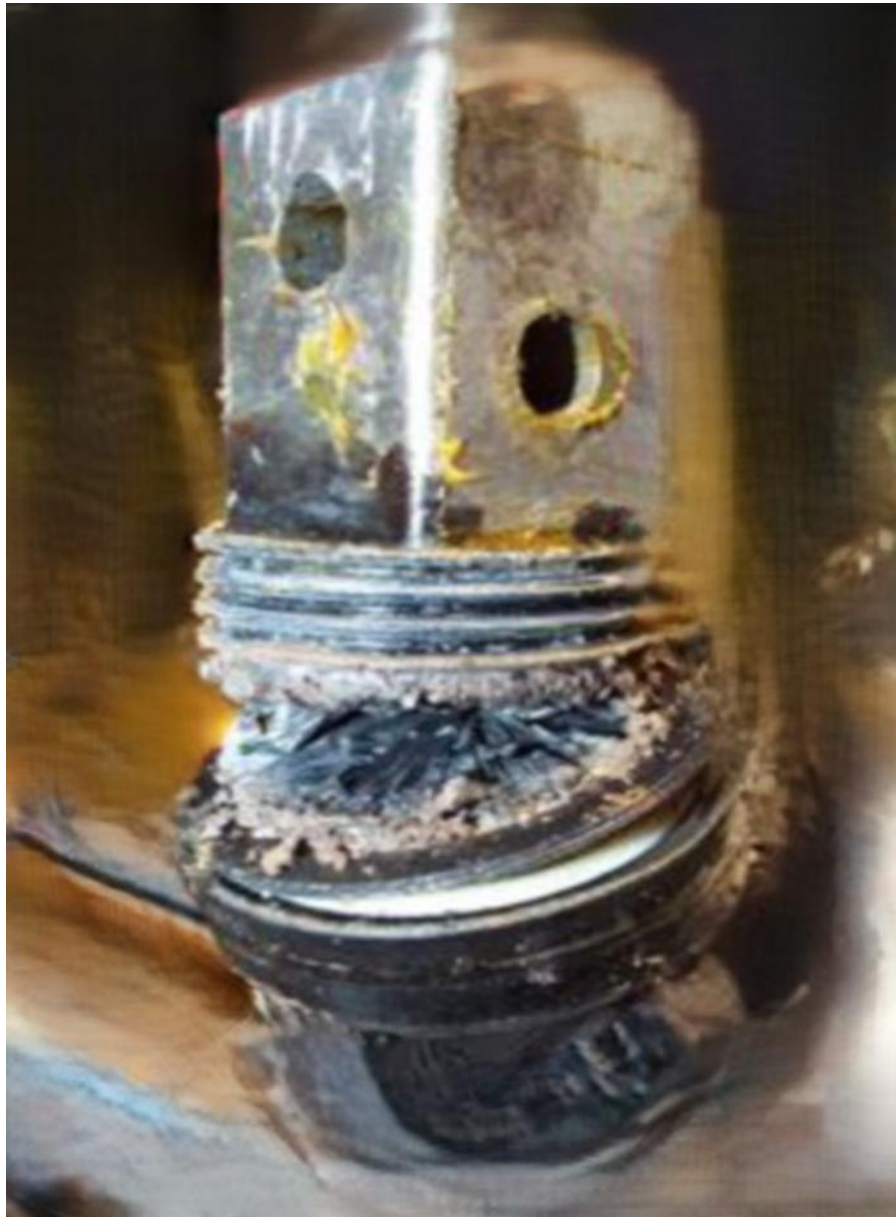
Figure 27 shows one of the positive posts in a two-post per polarity cell that was broken apart by simple hand applied pressure which demonstrates the fragility that can be caused by nodular corrosion. As can be seen there is some slight creep corrosion on the post.

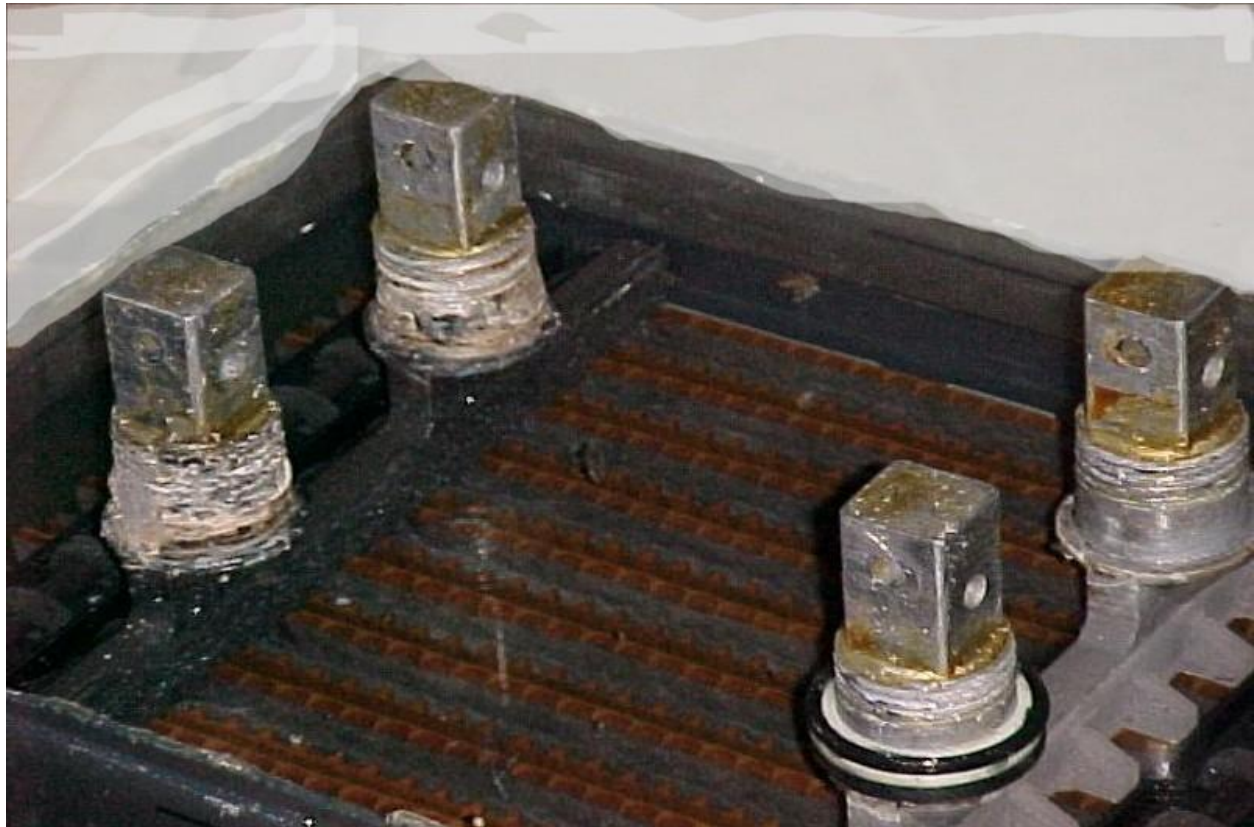
Figure 28 shows the difference between the posts in a cell that has nodular corrosion. The posts on the right are the negative posts. Nodular corrosion does not impact the negative posts. Notice how smooth the bottom area is of those posts and how sharp the threads are. The posts on the left are positive posts and have advanced nodular corrosion. The lower portion of the posts are deformed, as nodular corrosion is present in those areas. As can be seen the threaded area of these posts are degraded with advanced nodular corrosion. The post on the lower left is further advanced than the post on the upper left. The top threads on the post on the upper right still show some sharpness to some of its thread edges. This demonstrates that both posts in a cell with multiple posts per polarity do not have to be attacked equally.

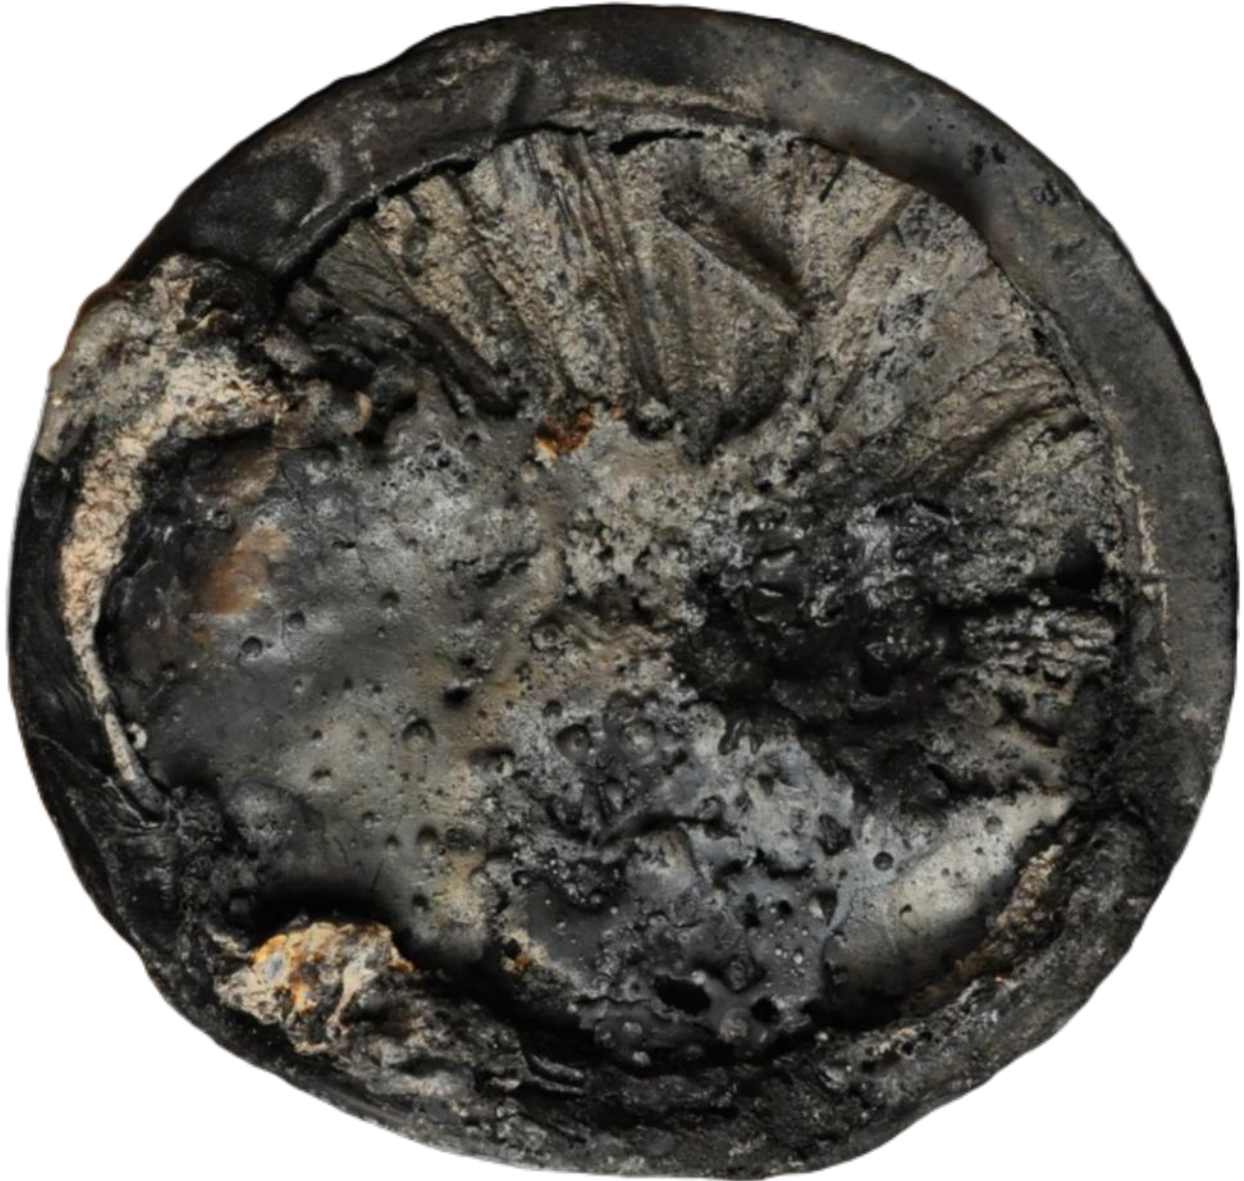
Figure 29 shows a post that was discovered during an online inspection of a battery whose cells had 2 posts per polarity. It was discovered during a normal online inspection and initially identified as “suspect” because the voltage was measured at above 3 volts, which flagged it for attention. The site repeated the measurements and observed that the voltage gradually decreasing until it eventually returned to within the average ICV range for the cells in the string. The cell was then removed from service for analysis, and this was discovered.

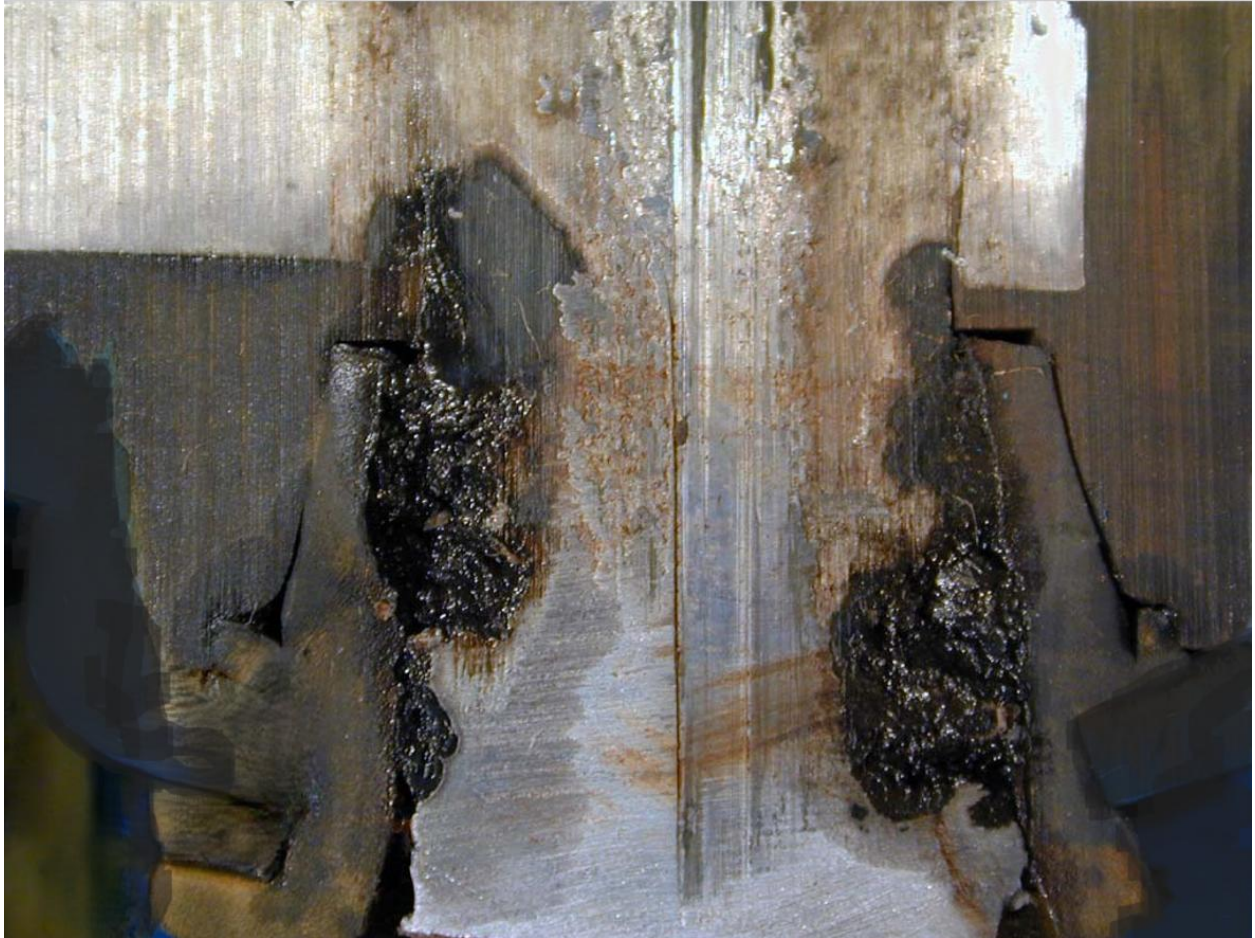
Figure 30 post attack that is not observable visually, but which can be measured electronically.

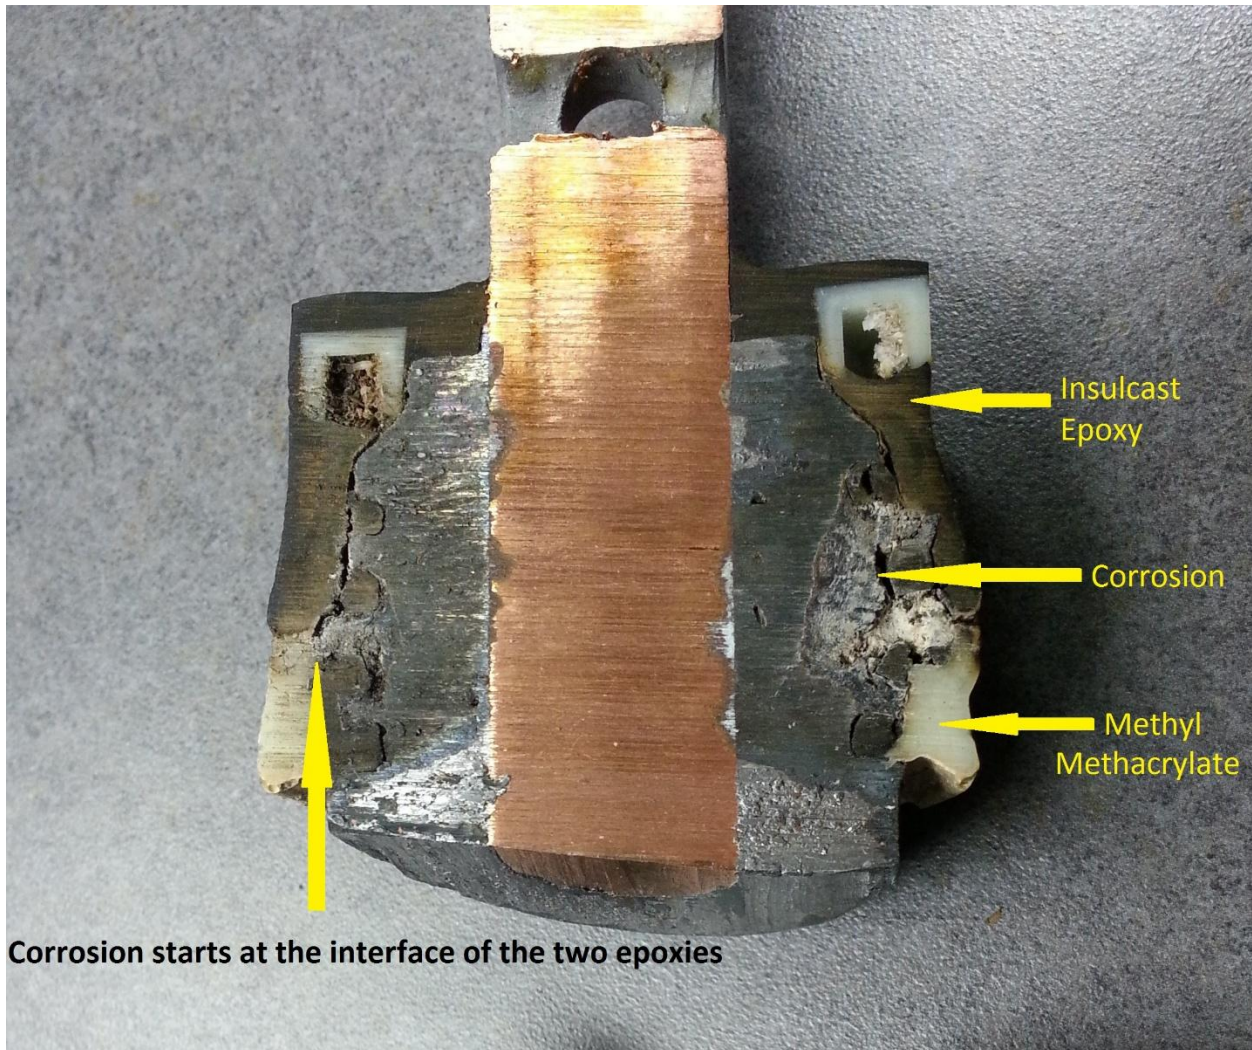
Figure 32 shows a vertically cut post that shows where the corrosion started in this post.

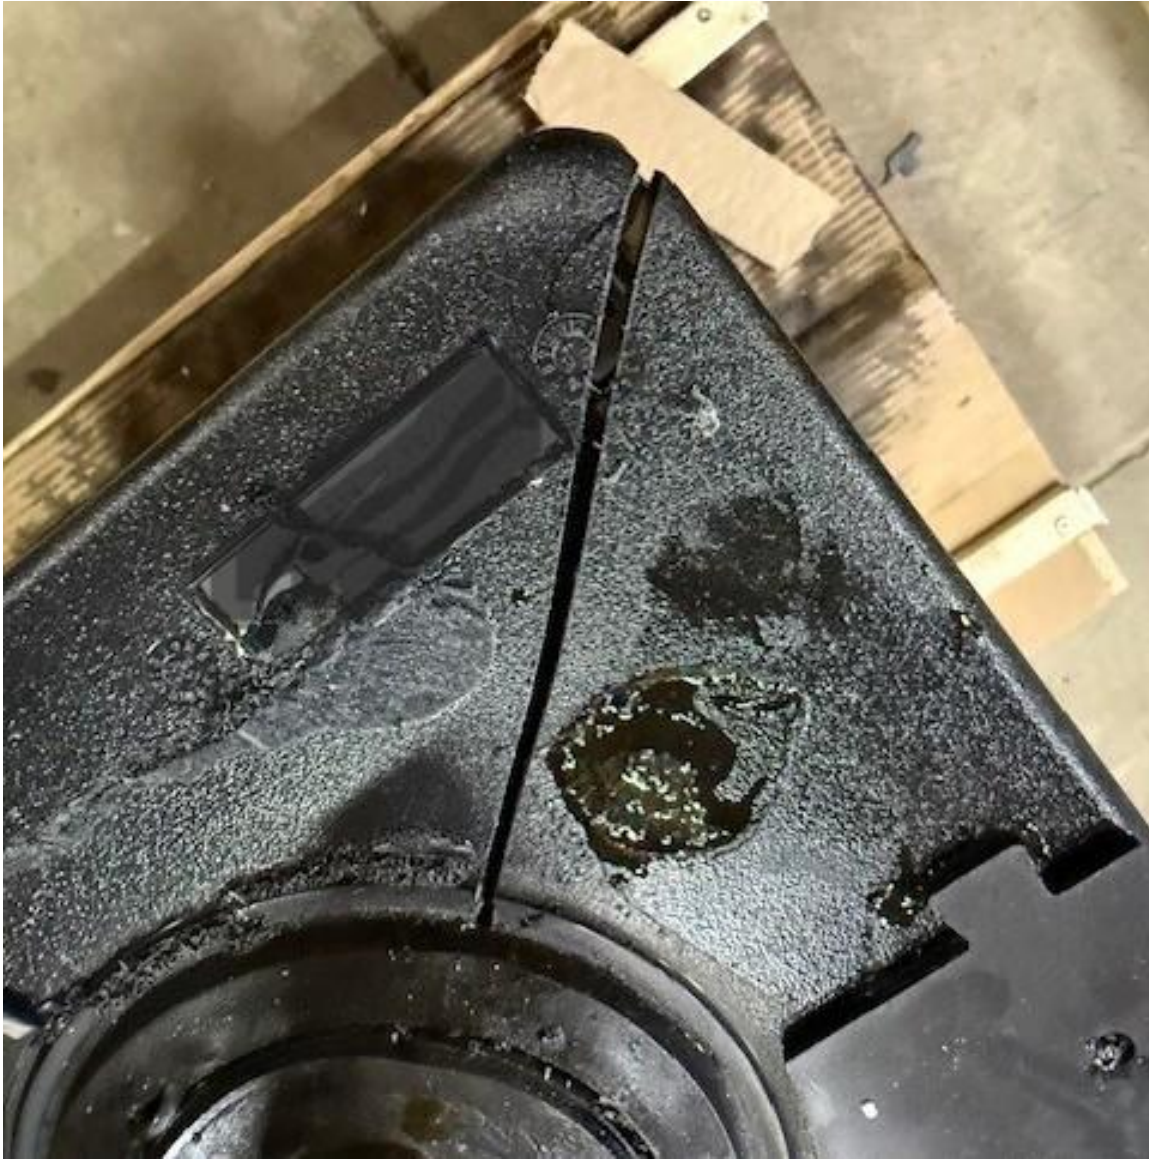
Figure 33 shows a cover with an extremely well-advanced crack that has turned at the edge of the cover and started down the side of the jar. This cell is over 19 years old.

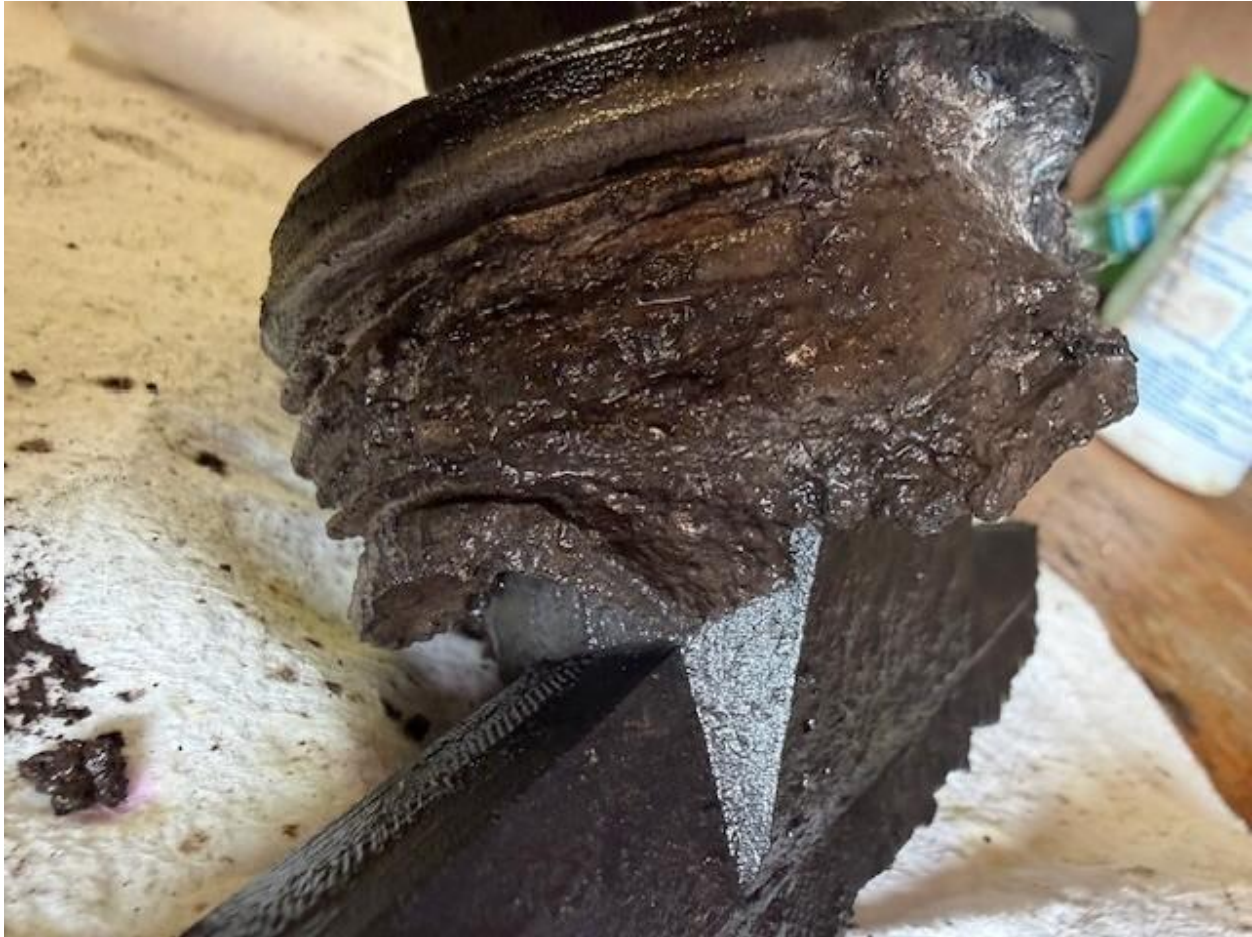
Figure 34 shows the side of the post seal for one of the positive posts in the cell in figure 33. In order to remove this post from the cell, the cover was cut away from the posts, and it took excessive pressure back and forth to break the post and the collector buss apart from the plates. The strength (fragility) of the post was not impacted by the corrosion because that was attacking the lead bushing in the cover and not the post. The resistance of this post was 49 microhms which demonstrated that there was no change from the baseline resistance range for this post.

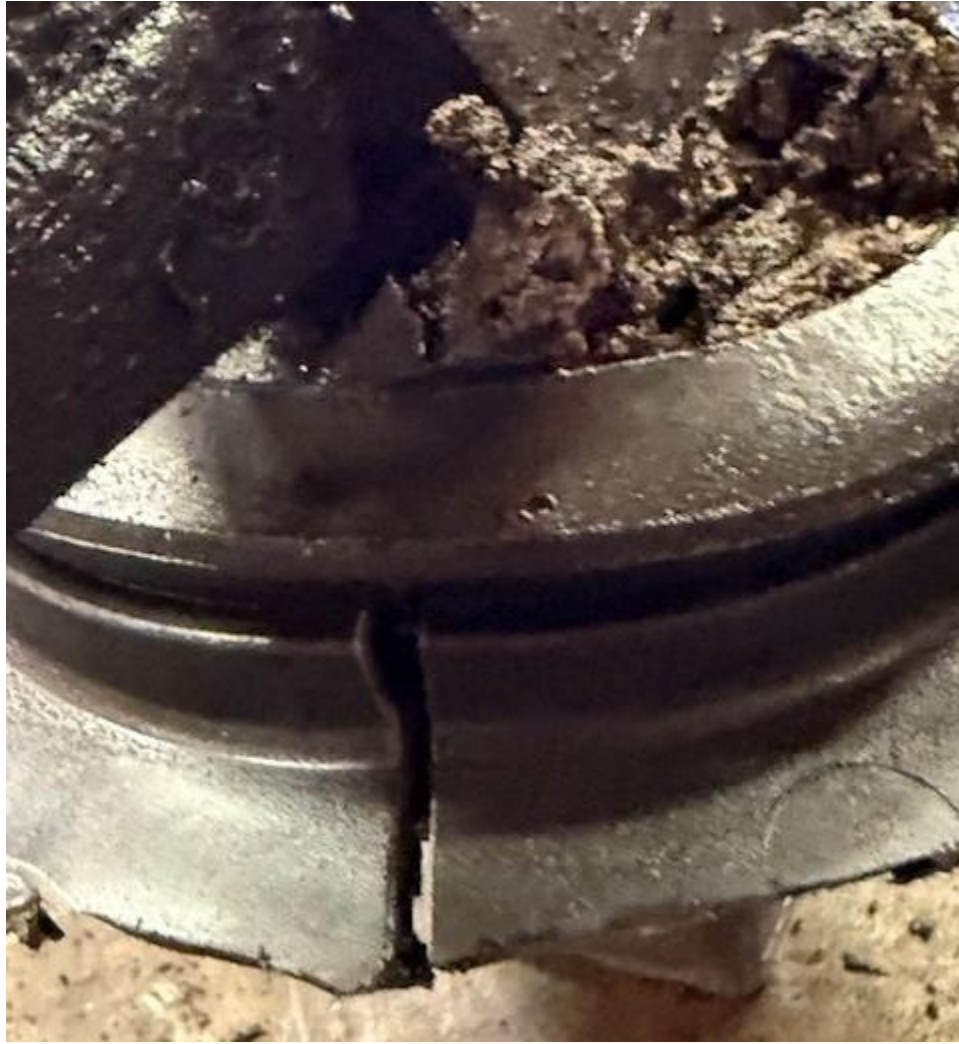
Figure 35 shows the other positive post of the cell in figure 33. The nodular corrosion was attacking the lead bushing in the cover, not attacking the post itself. The resistance of this post was 51 microhms, which again demonstrated no change from the baseline resistance range for this post.

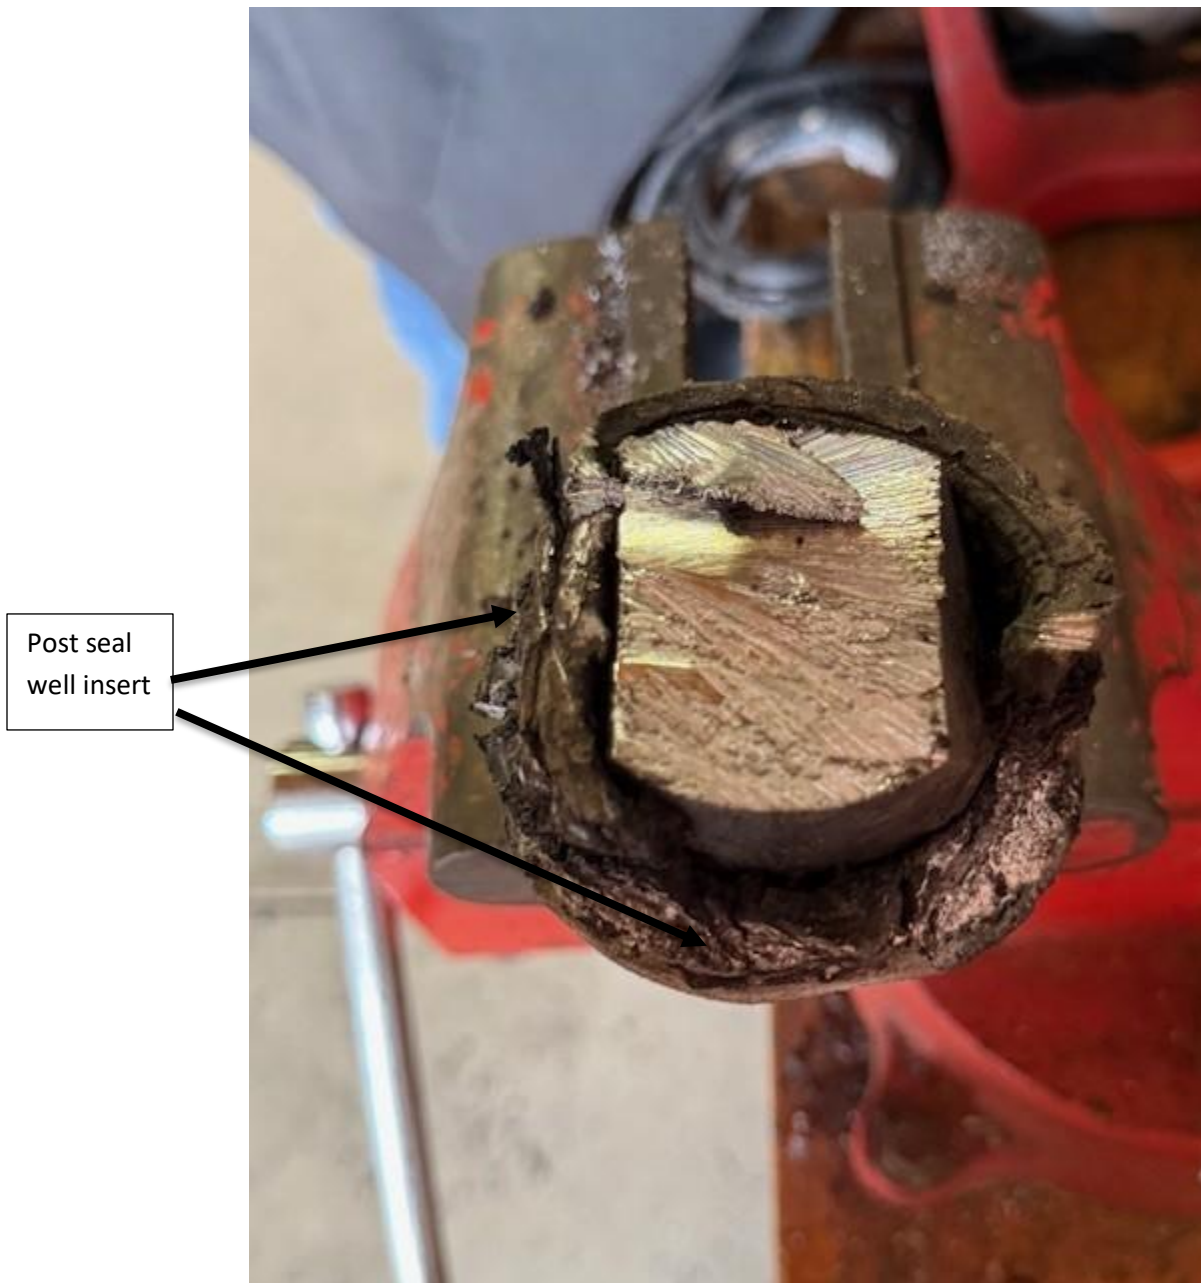
Figure 36 shows the horizontal cut through the post shown in figure 34. The resistance of this post was 49 microhms. As can be seen, in this case the nodular corrosion was attacking the post seal well insert, not the post.

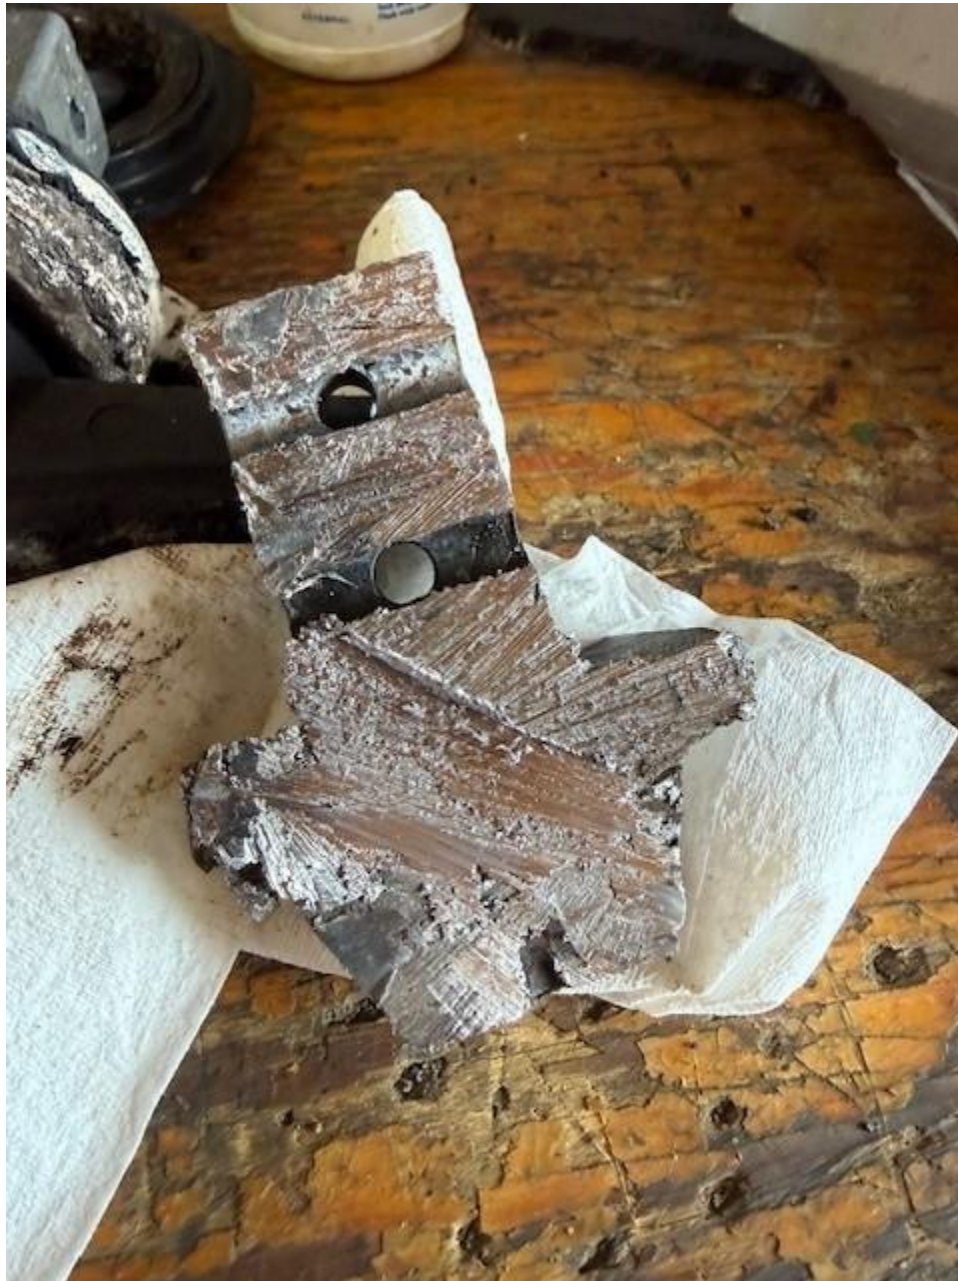
Figure 37 shows the vertical cut through this post. The resistance of this post was 51 microohms
