bestmag

No. 88 Spring 2025

Recombiner performance during normal and abnormal conditions

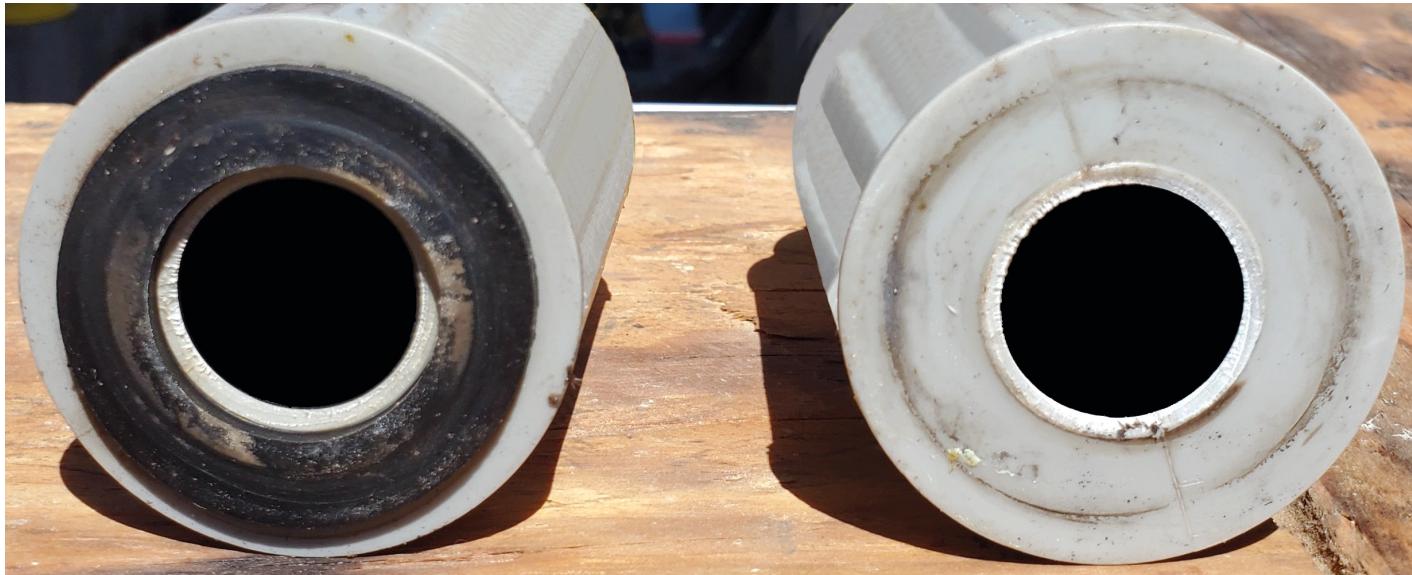
Pic 3: This picture shows two units from an off-grid site that when being removed from their cells, separated the body from the base. It is our belief that the plastic was negatively impacted due to excessive internal heat generation.

The first picture that we saw of this off-grid battery showed three recombiners and the base (the part that secures the assembly onto the cover, were gone from the recombiner, and were reported as being inside the cells. It was explained that when the individual that owned the battery went to check the electrolyte levels in the cells that three of the recombiners simply broke apart when he twisted them to remove them. The remainder of the units came out as they normally do.

That picture showed what appeared to be a clean separation, with no indicator of the cause. There was another picture that showed the inside of one of the recombiners. The user had been instructed to cut one apart and take pictures and send them to the manufacturer. At first glance, that picture appeared that everything in there looked normal. However, later on, while looking at that picture with more magnification, it was noticed that there were three of the raised support structure ribs, that showed some slight irregularities. Those irregularities were dimples on the top of those ribs. Those dimples looked like they were the beginning of the

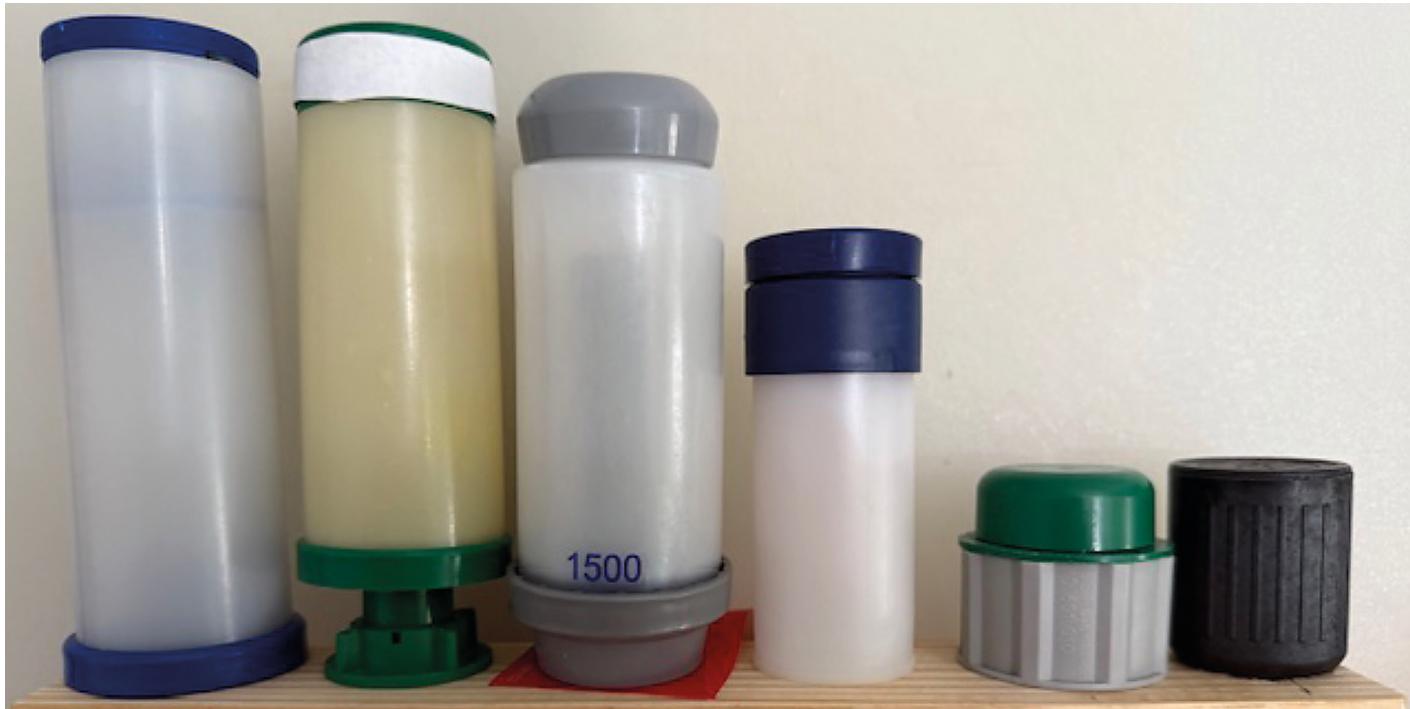
Fig 1 shows a recombiner from each of the six manufacturers

that we are aware of. Each of the units shown has the capability to recombine the gases generated during normal operations for up to approximately 1,500Ah. There is a total of 10 different recombiner models available that we are aware of presently. Three of the manufacturers have other models, with one having one lower amp hour model, one having two lower amp hour models, and one having a larger amp hour model.

As can be seen by the differences in the physical size of the recombiners, size does not dictate how much gas a unit can recombine back into water. In addition, how a recombiner looks does not indicate its ability to safely function during any of the three abnormal events described in the Spring edition. Those three events being:

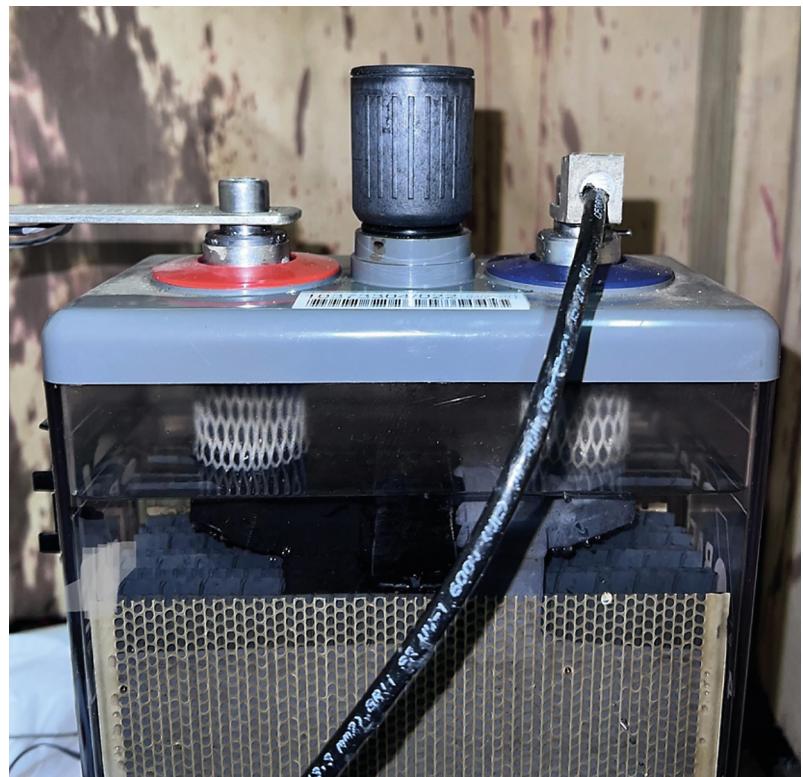
Fig 2 shows our test set up. We inserted the recombiner to be tested into the cell and proceeded to increase the current flow to that desired for the respective test and then monitored the recombiner case temperature throughout the test.

We utilised lead-selenium instead of lead-calcium cells for our test cells, so that we could observe whether the Arsine or Stibine gas would be controlled by the filtering material utilised to protect the catalyst material. Pass/fail criteria:
