REDUCING THE WATER USAGE IN UPS VENTED LEAD-ACID BATTERIES

William Cantor
Engineer
TPI
Exton, PA

This paper documents a field experiment utilizing VLA UPS batteries to compare water usage through lowering the float voltage and/or replacing the flame arrestors with recombination vents.

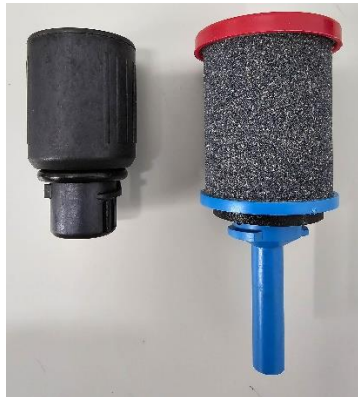
The reason periodic water additions are required is because water is converted into hydrogen and oxygen during the float charging process. Recombination vents are replacements for the standard flame arrestor vents. A catalyst is embedded in the recombination vents which recombines a high percentage of hydrogen and oxygen back into water vapor, thereby reducing water usage and hydrogen generation. A recombinant vent (left) is shown with a standard flame arrestor (right) is Figure 1.

Figure 1 recombinant vent vs. flame arrestor

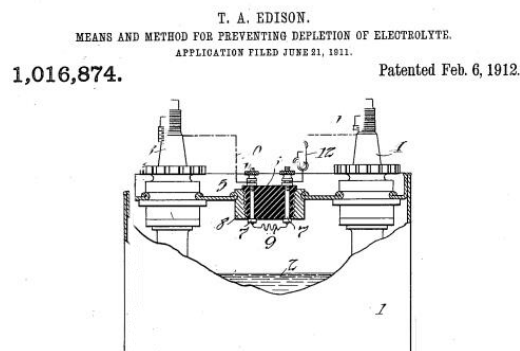
The use of catalysts has been studied and used in VRLA batteries for some time [2]. In fact, Thomas Edison [3] was granted a patent in 1912 for recombining hydrogen and oxygen, see Figure 2. Catalysts installed in VRLA batteries have been used for more than 20 years to reduce water loss, among other things. Since VRLA batteries are not designed for water additions, a method to reduce water loss is essential.

Figure 2 Edison Patent of 1912

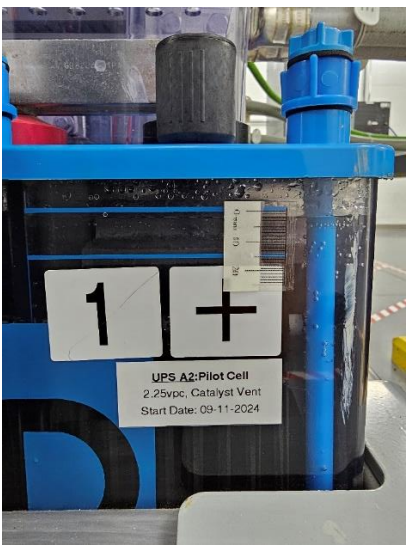
At the start of the experiment, all cells were filled to the top line. A measurement guide (with mm marks) was placed on 25 cells per string and is shown in figures 3 and 4.

Figure 3 Measurement guide for electrolyte levels

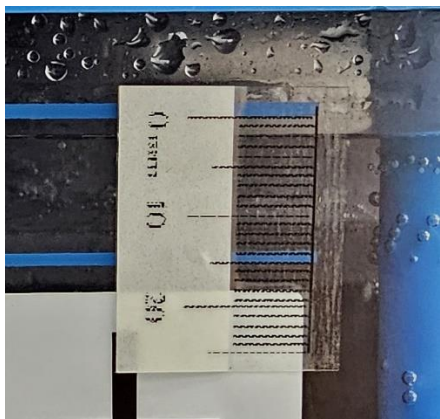
Figure 4 Measurement guide close-up

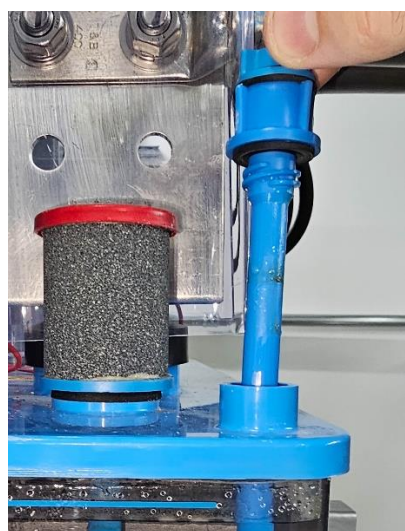
It was decided by the team that the sampling tubes would be removed and when the caps were replaced, they were torqued to the manufacturer's specification. These actions solved the problem, but the initial issue caused a lot of work between cleaning and neutralizing the electrolyte overflow and pulling the sampling tubes from 480 cells. Picture of the sample tubes before and after removal are shown in Figures 5 and 6.

Figure 5 Sample Tube

The recombiner vents have a pressure vent that opens at 0.07 psi. While this is a small amount of back pressure, the relationship between pressure and height of water is 27.708 inches per psi. To convert this from water to electrolyte, you need to divide by the specific gravity. The result is about 1.6 inches of electrolyte rise in the sampling tube. Given that all cells were filled to the high line, this was enough to push the level of electrolyte to the top of the sampling tubes. Although there were caps at the top of the sampling tubes, they did not contain the rising electrolyte. Part of the problem may have been that the caps were not torqued to the specification. There was also evidence that the threading for the caps was sub-optimal; burs were noted on some of the cap threading. Those would prevent the caps from making a perfect seal, despite the rubber O-ring. Whatever the case may be, the result was electrolyte escaping the cell.

Our organization has over 30 years of experience measuring specific gravities and we can find no technical reason that sampling tubes are needed. We realize that some organizations may utilize them in their maintenance practices, but it should be discontinued because there is little or no value in their use. Removal of the sampling tubes will allow all VLA battery manufacturers to remove the tubes completely which would eliminate another source of leaks and probably save the manufacturer and users some money. Sampling tubes are uncommon in Europe.

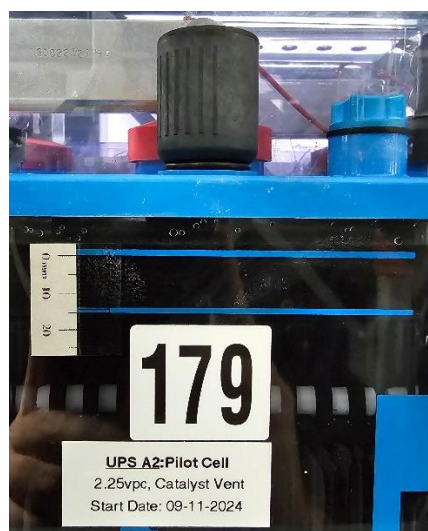
Figure 6 Sample Tube Removed

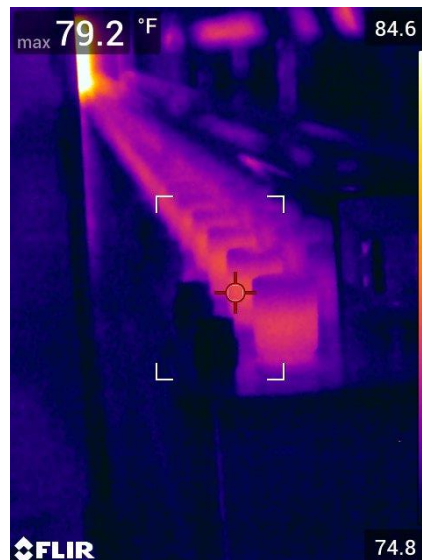
The recombination of hydrogen and oxygen into water vapor is an exothermic reaction and heating does occur. Under normal conditions, the heating is not a concern as shown in figure 7. Under abnormal conditions, excessive heating can occur [8] and has shown to cause irreversible damage to in some models.

Figure 7 Nominal heating under normal conditions

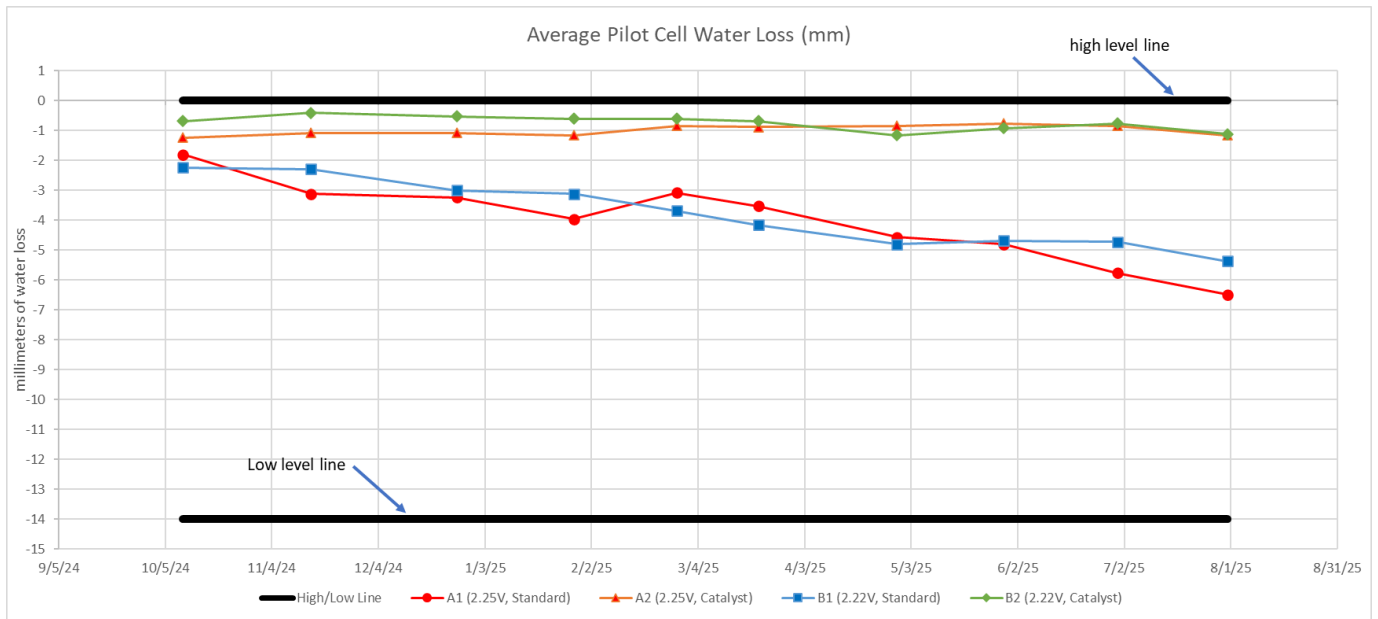
The main objective of this project was to limit the water loss of a vented lead-acid UPS battery. Figure 8 is a summary of the water usage over the first nine months of the project. The water loss is recorded for every 10th cell and then averaged to obtain the string average as shown in Figure 8.

Figure 8 Average Pilot Cell Water Loss (mm)

While Figure 8 only shows the designated pilot cells for every string, the other cells in the string are routinely checked for any significant deviations from the pilot cells, and none have been found to date.

The data clearly show that little or no water loss has occurred in strings where the recombiners are used. There was an initial drop of about 1 mm but that was most likely a combination of some settling and loss from the initial overflow and removal of the sampling tubes. It is difficult to extrapolate the time until water replenishment is needed (at about -15 mm), the data seems to indicate that 1 mm water loss per year would not be an unreasonable assumption. This rate of loss may increase as the cell ages and float current increases. However, a ten-year-or-longer interval might be possible given the results to date.

On the other hand, lowering the voltage to 2.22 volts per cell average has no effect on the water loss. Water loss correlates with the use of the recombiners and is not dependent on the float voltage.

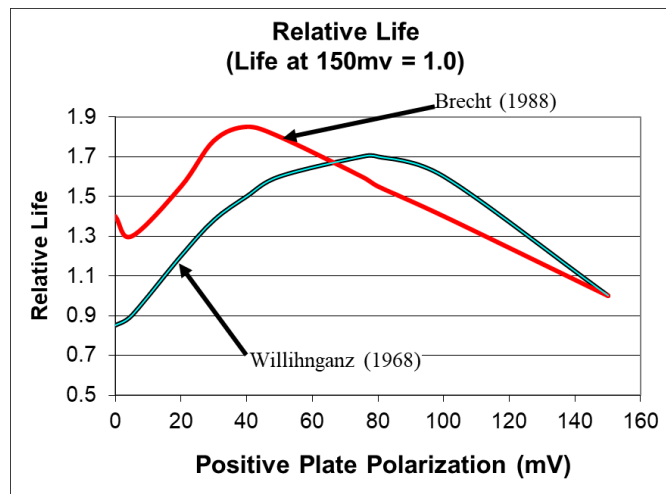
Research[9, 10] has shown that amount of positive plate polarization can significantly affect battery life. The amount of negative plate polarizations does not affect life so as long as they are not depolarized. A low or high positive plate polarization can reduce life significantly, see figure 9. The total polarization of the cell is the voltage applied above the open circuit voltage. For 1.250 specific gravity cells, the open circuit voltage is approximately 2.10 volts and therefore the total polarization is 150 millivolts for cells charged at 2.25 volts and 120 millivolts for cell charged at 2.22 volts. The total cell polarization is divided between the positive and the negative plates.

Figure 9 Relative life vs Positive Plate Polarization[9]

The data from the lab suggests that the lower positive polarization will increase the life up to 30%. More investigation needs to be done in this area to make a definitive conclusion.

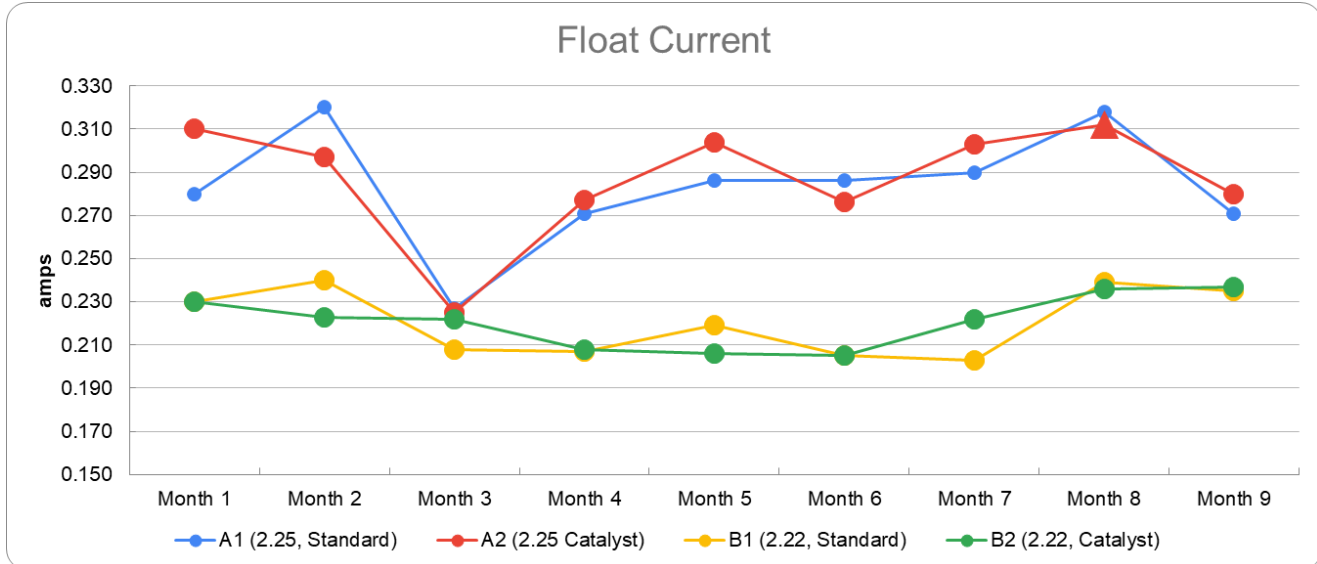
String float current is also important to the discussion of plate polarizations. As was mentioned earlier in this paper, measuring float current on these batteries is challenging between the large amount of noise and the large conductors. Figure 10 is the measured string float current over time. While there are some variabilities with the data, the string current for 2.22 strings (B1, B2) were about 64 millivolts lower than the 2.25 strings (A1, A2) on average. Assuming the Tafel curve for the positive plates has a constant slope, one would expect that the positive plate polarizations would be decreasing at the lower float voltage, consistent with the lab data.

Figure 10 String Float Current
